# Westland West Extension Drum Screen Refurbishment 4 ea. 9' dia. 12' wide drums

by Bob Haverfield, D (DFW)

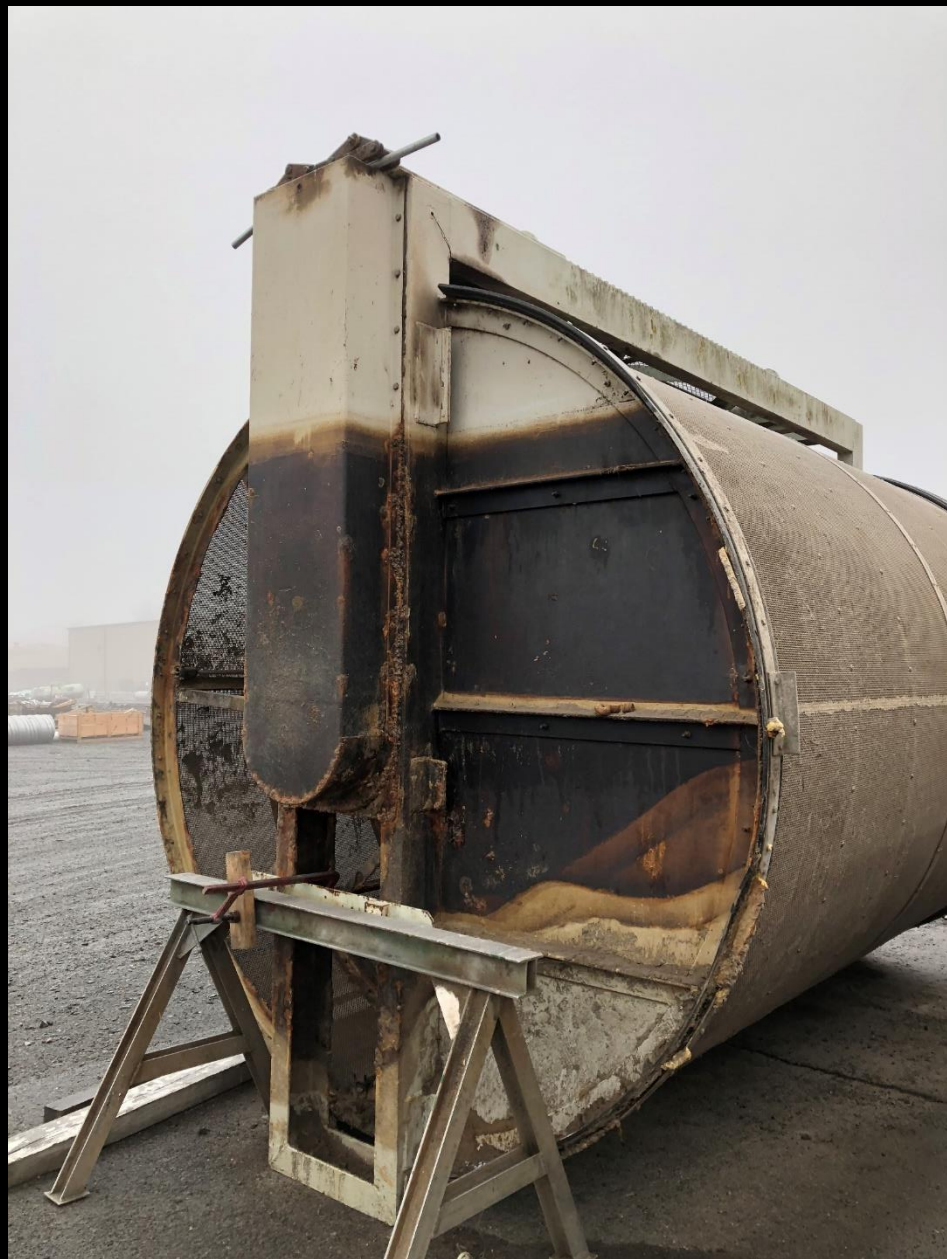
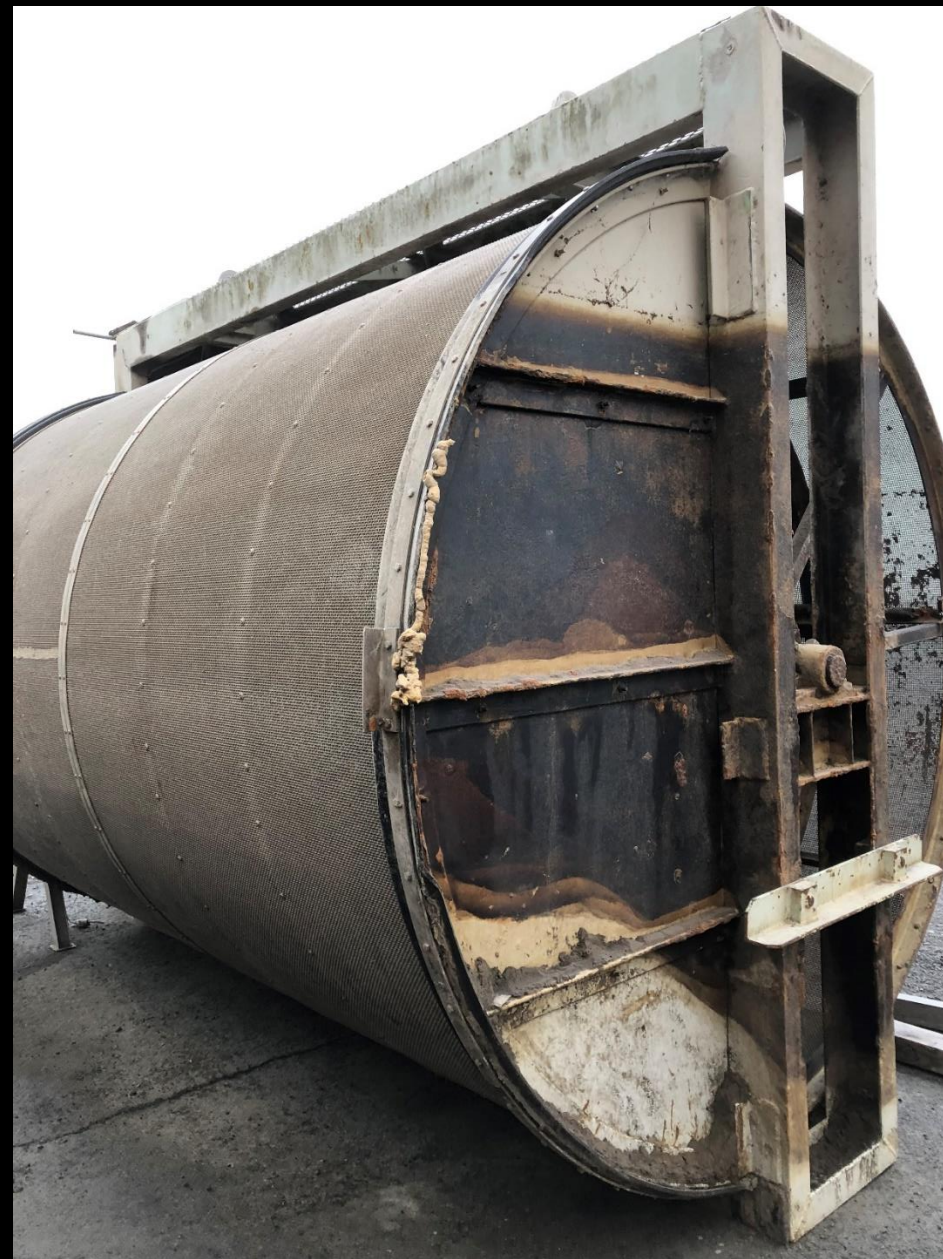
This is what we started with.

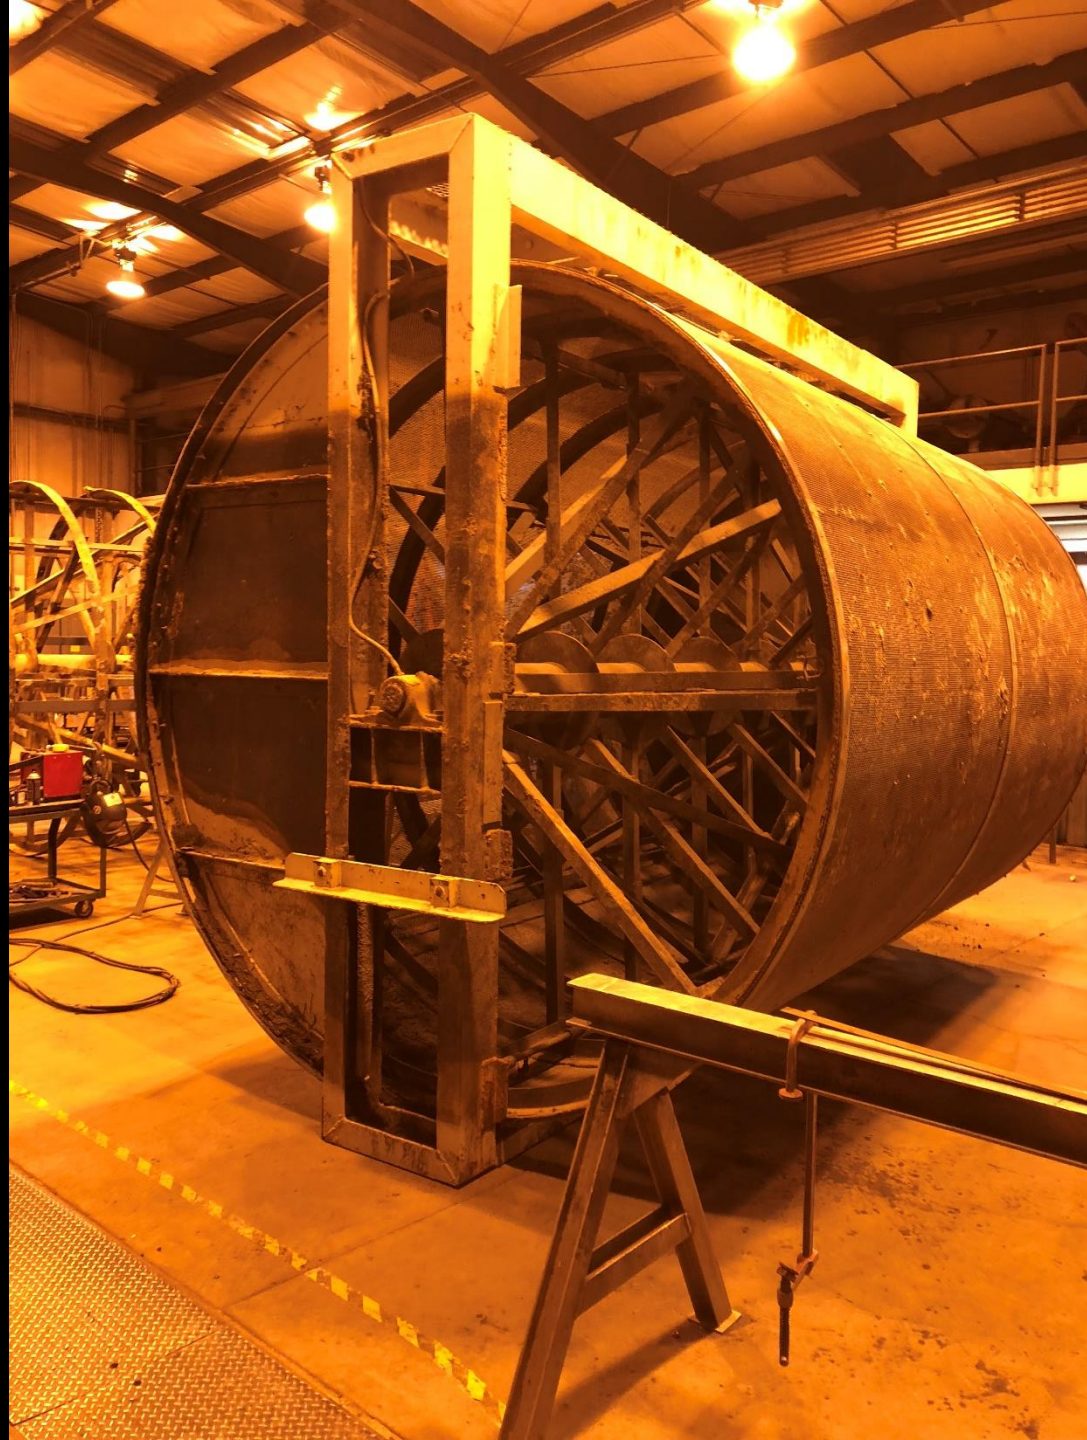
And it doesn't get any better.

As you can see we had a little rust problem

Not much of the magnesium  
anodes rods left.

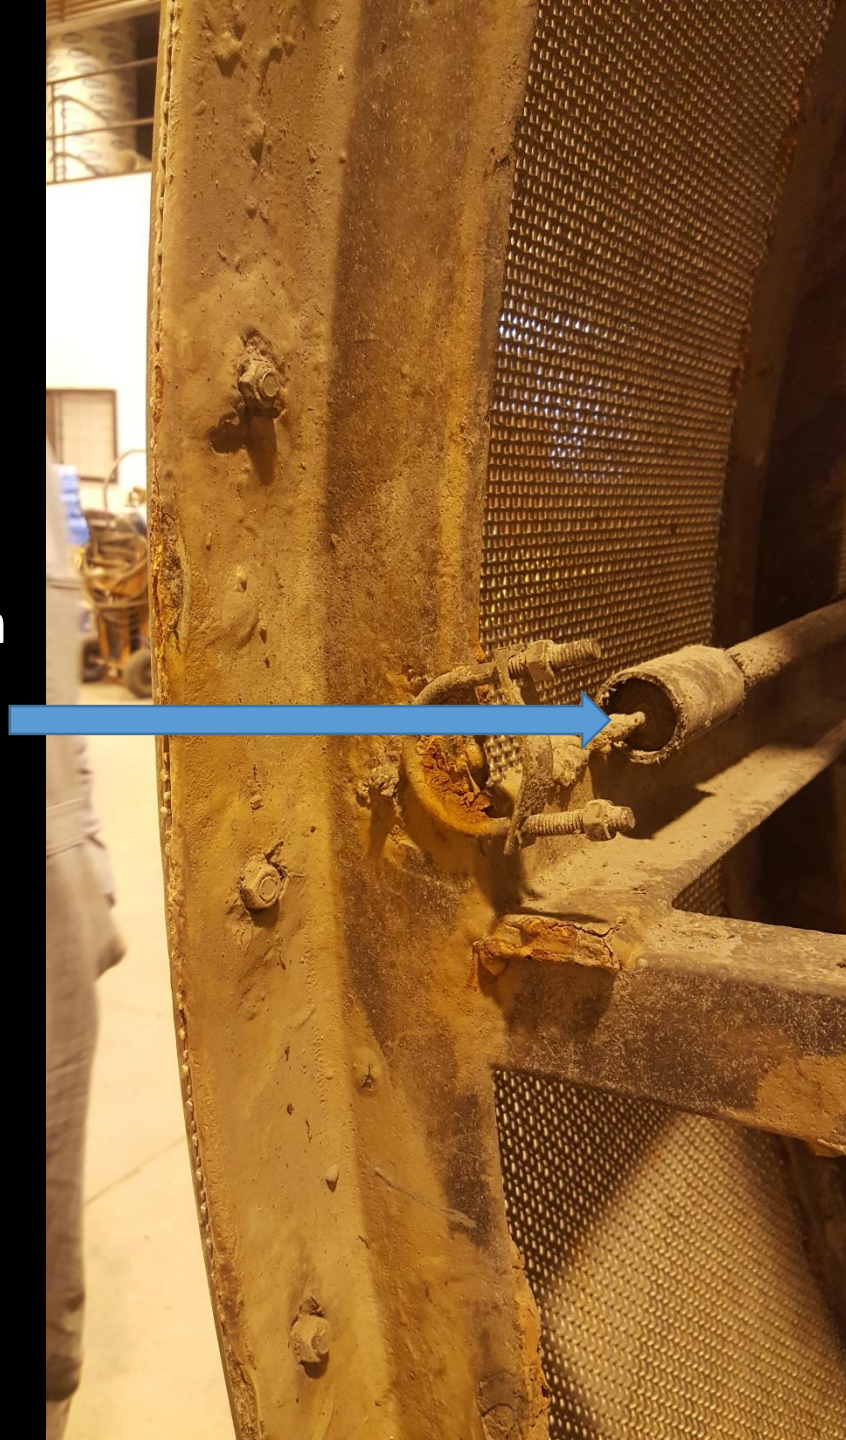
The screens were covered with woven stainless wire  
Which was removed and scraped

There were  $\frac{1}{4}$ "x2" rolled flat bar for the  
side seal to ride on.

There was two 1/8"x1" stainless flat bars  
covering the ends of the woven wire at the center of the drum.

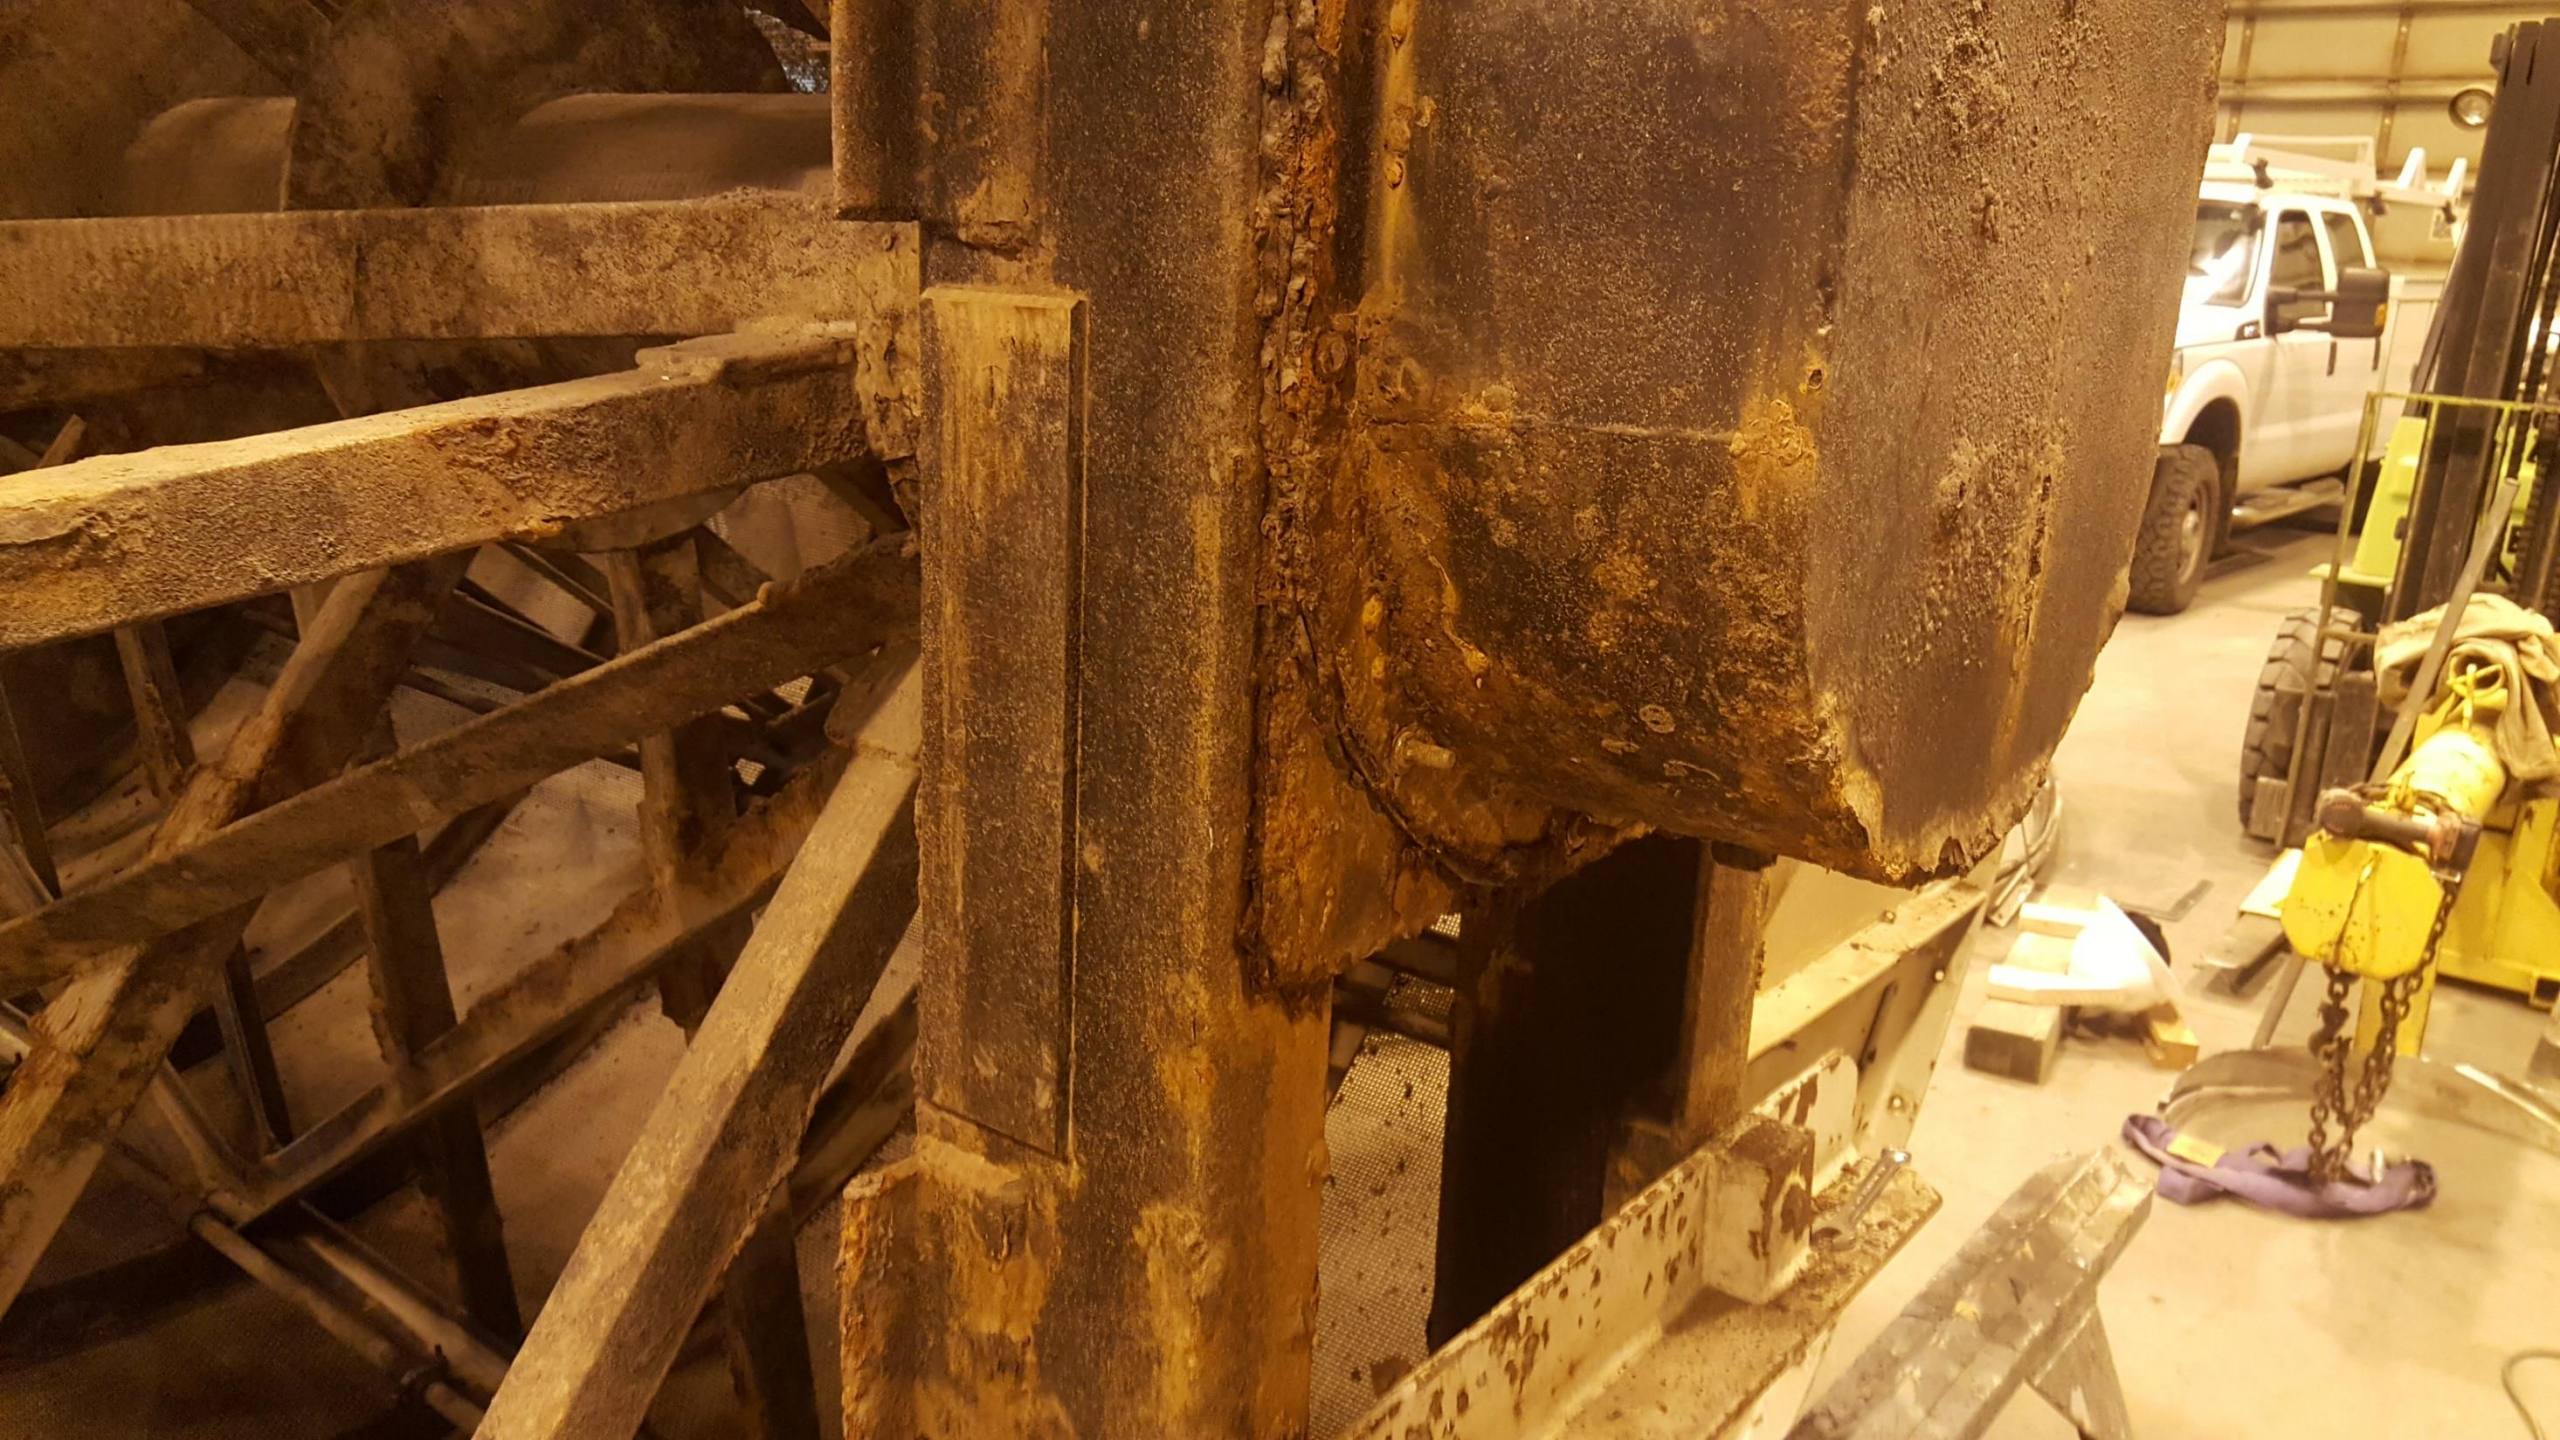
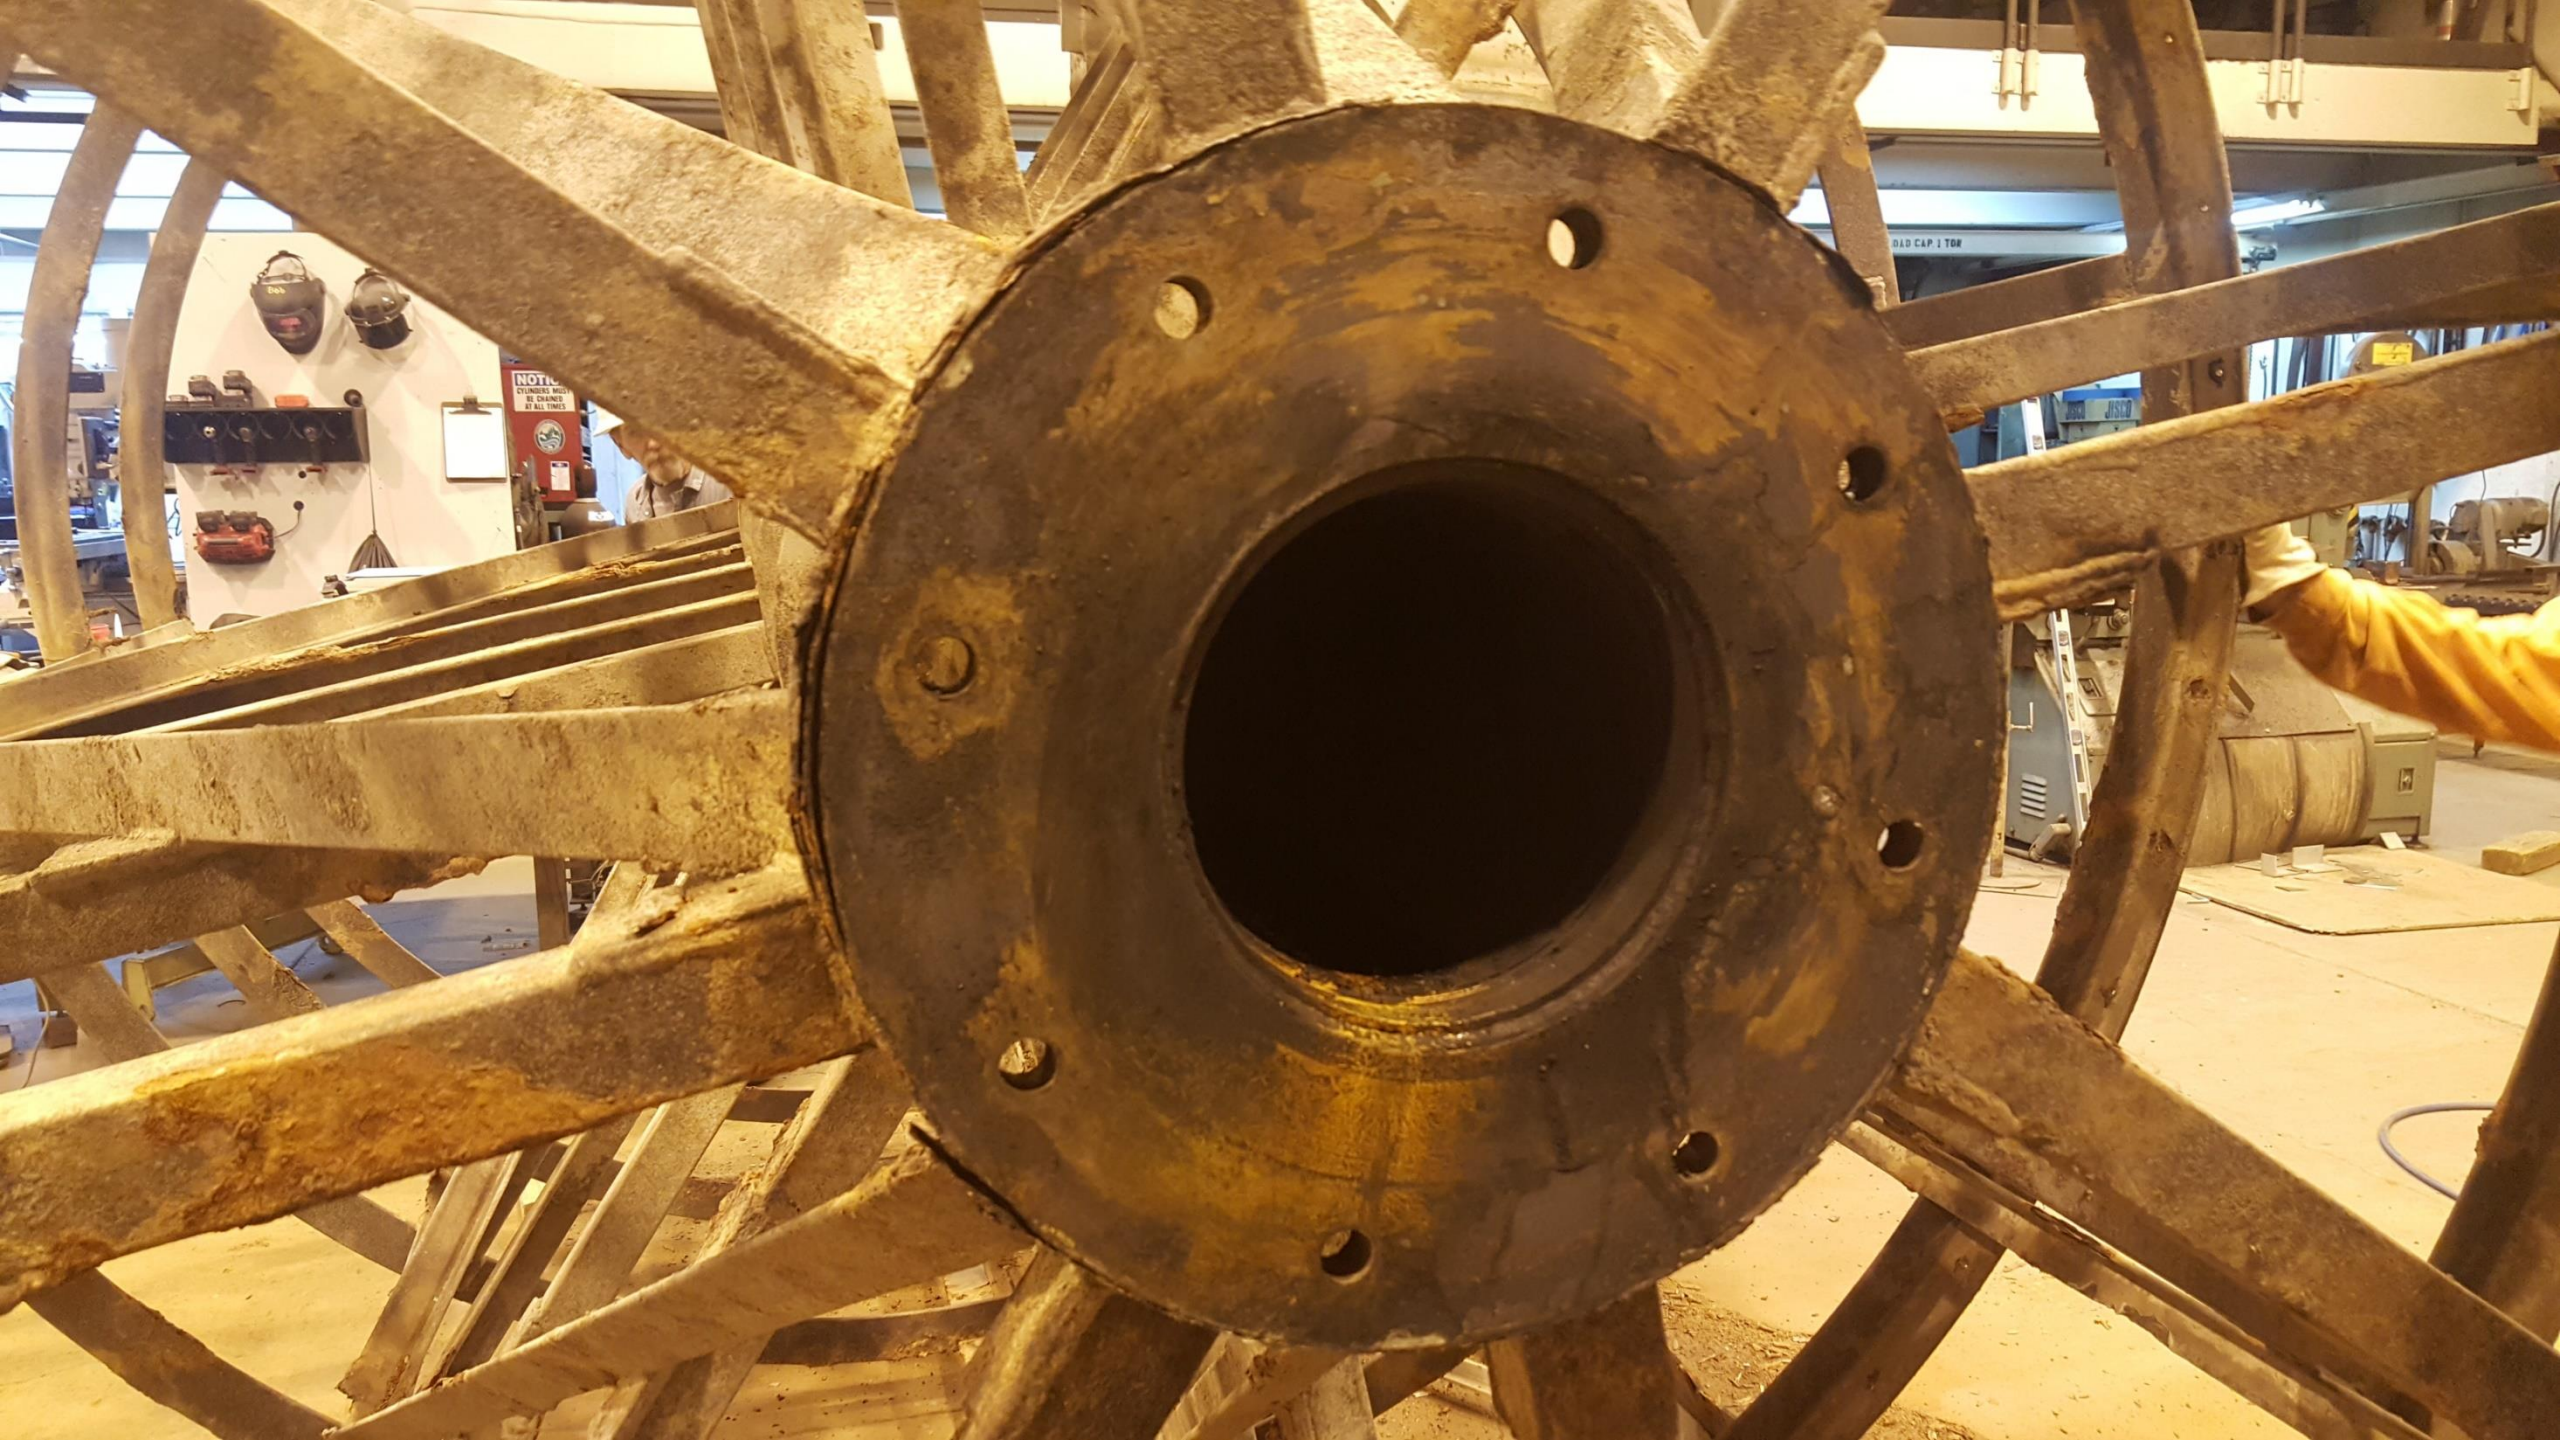
Most of the fasteners where in bad shape.

Machined to fit into the center drum tube.

Some of the shafts had to be built up and machined.

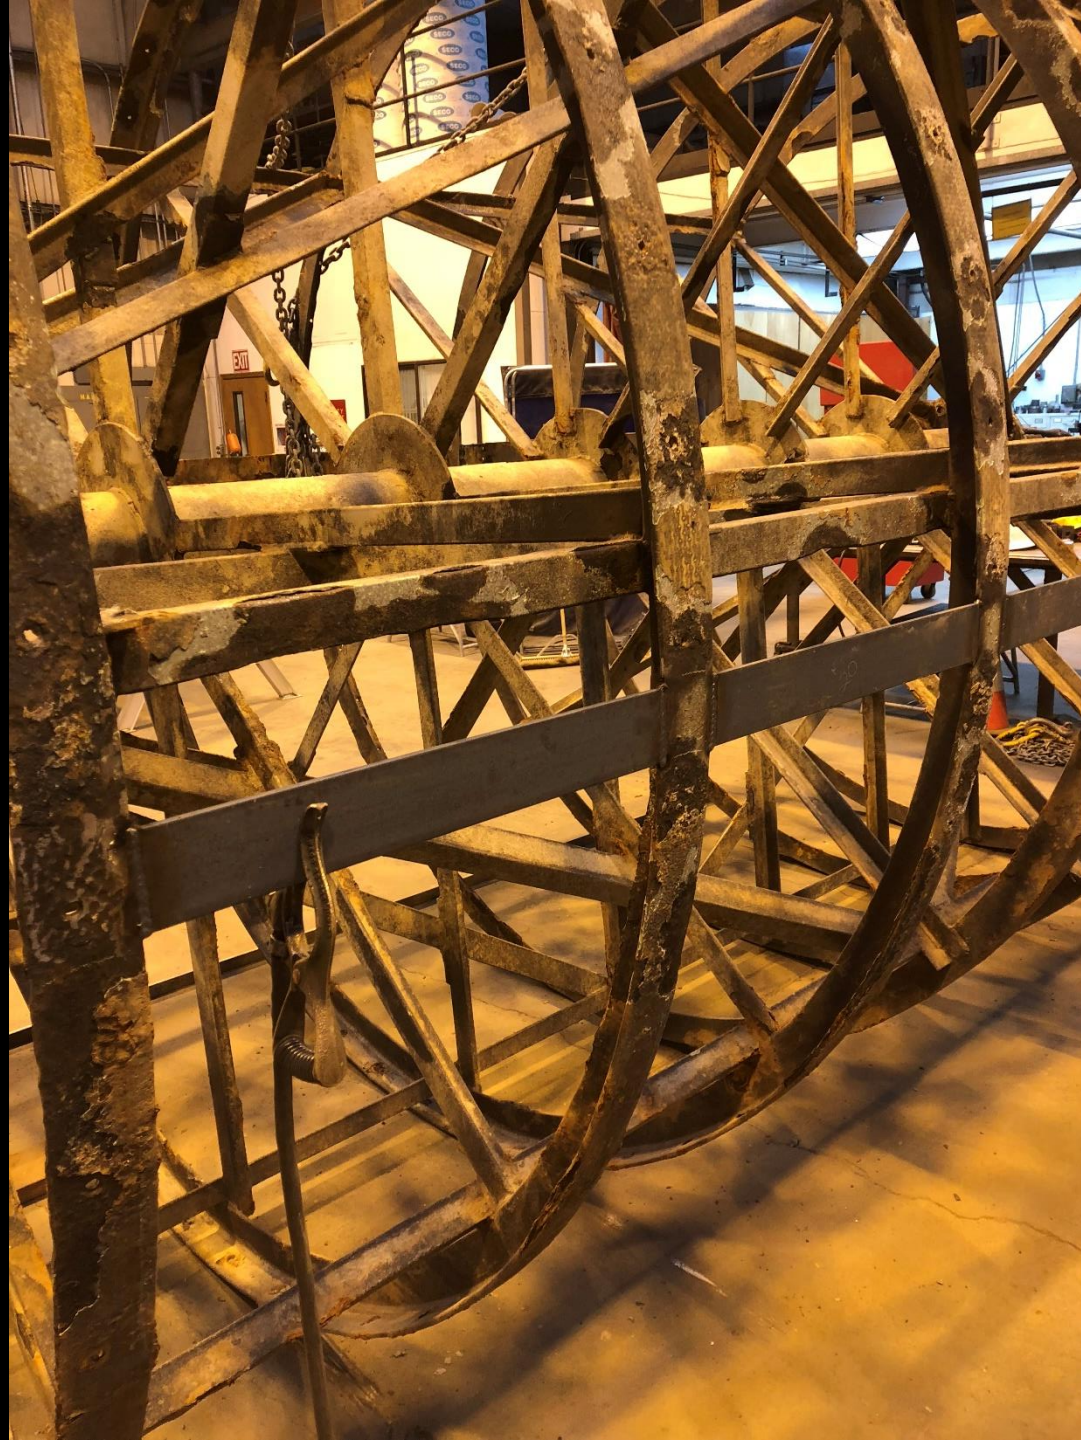
Not sure what it is,  
I think it was lead.

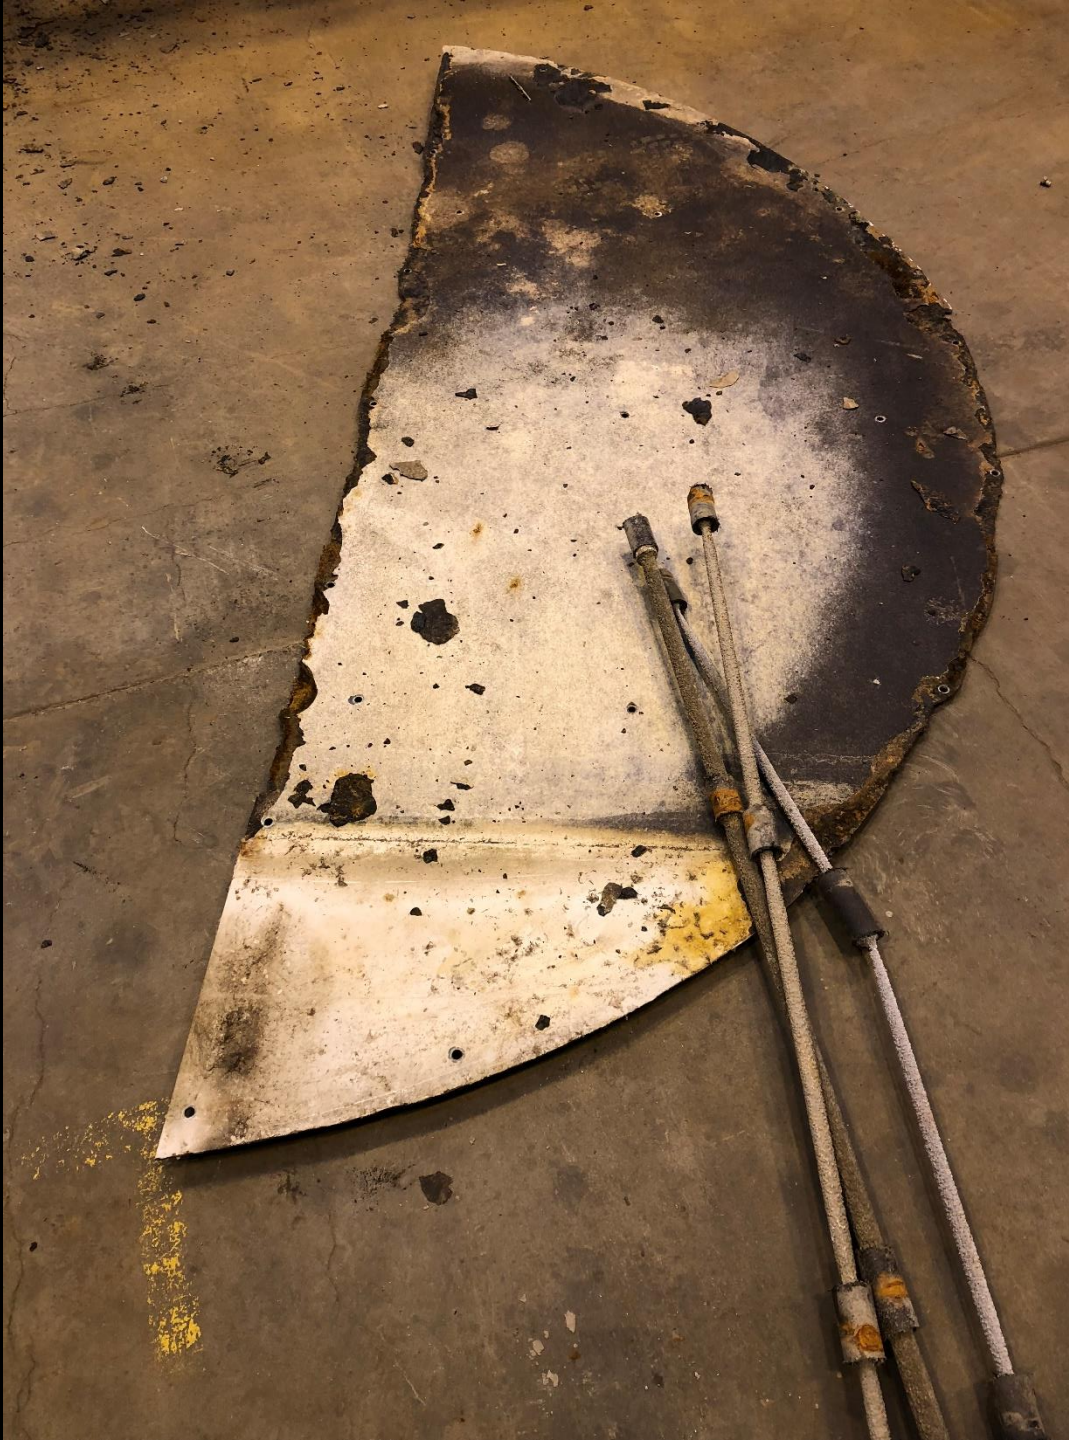
This is the frame all one unit.

Old wing plate and anodes

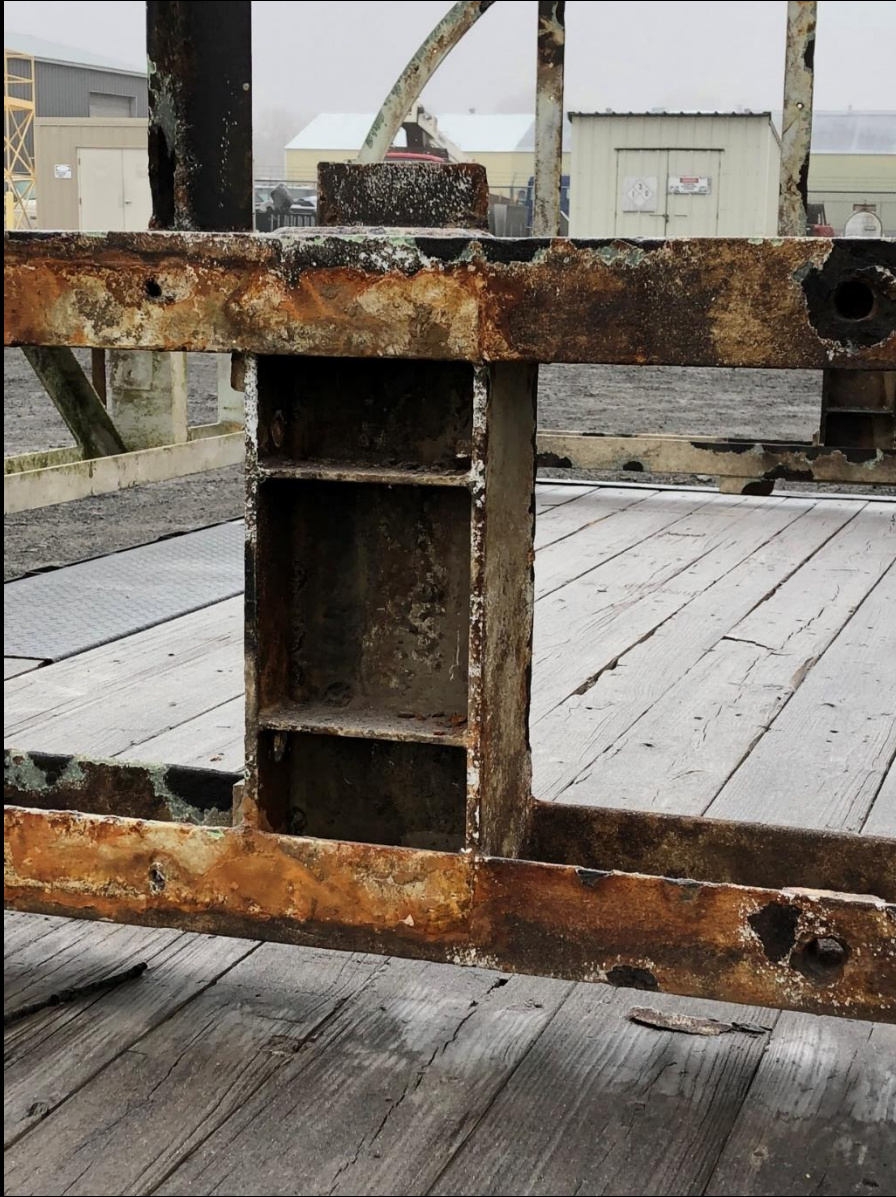
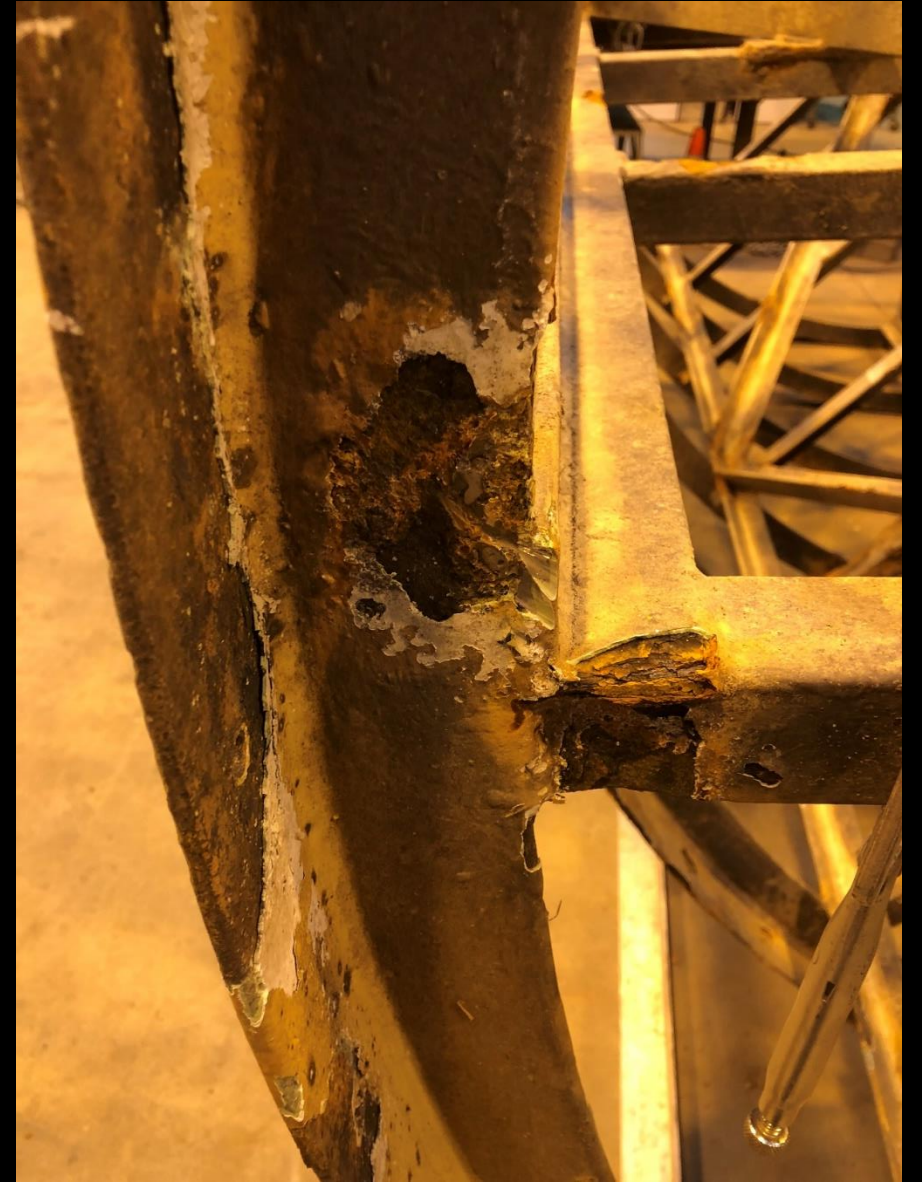
Some of the rust damage.

2 units headed for blast and coating.

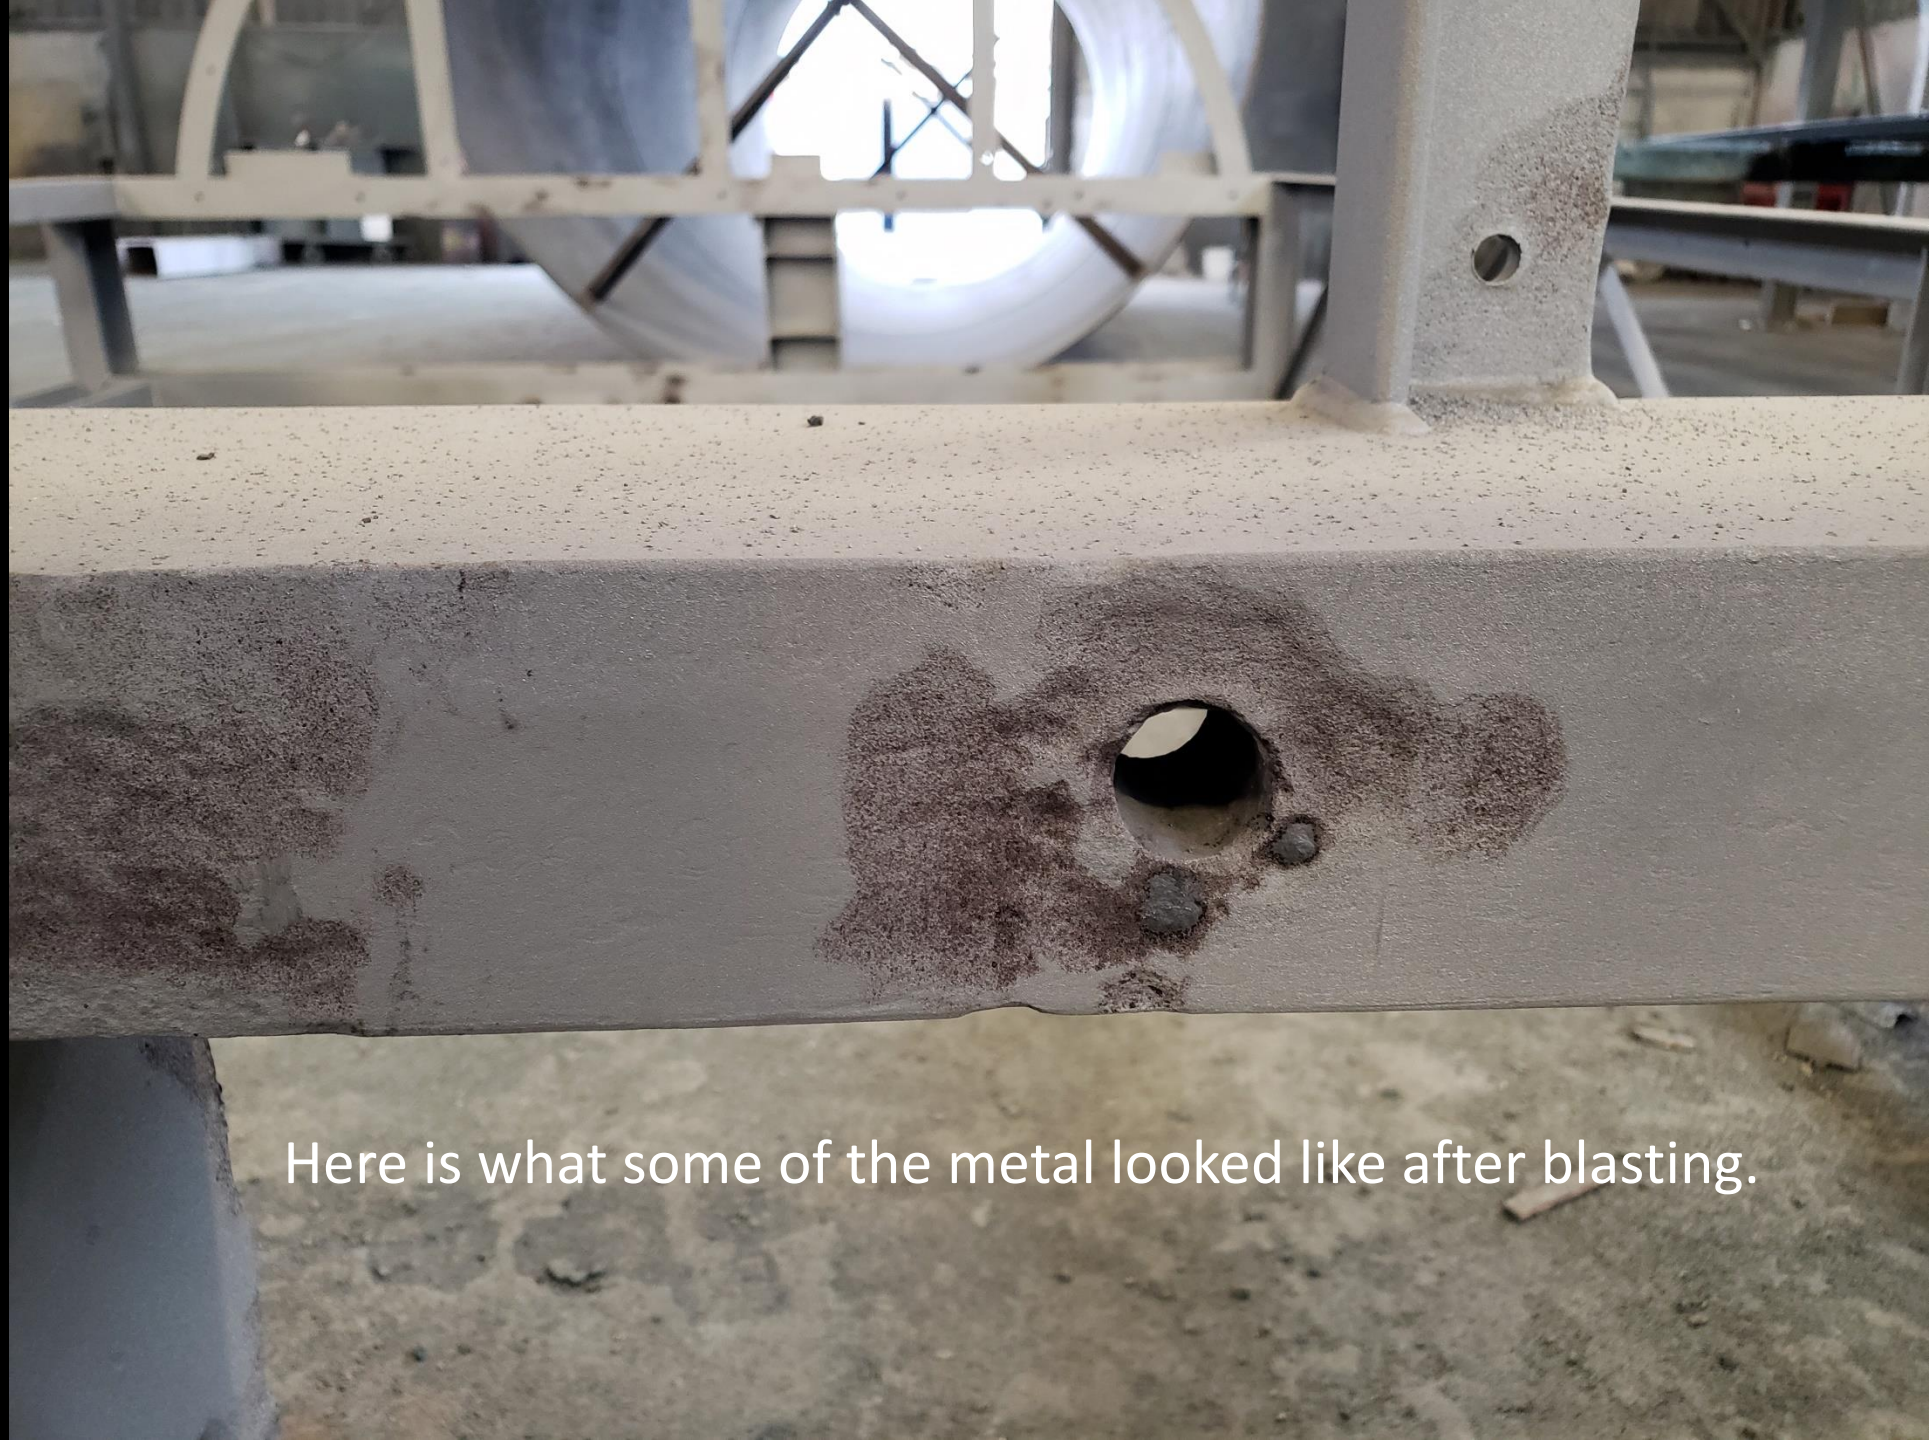
Here is what some of the metal looked like after blasting.

Chain covers had to be patched.

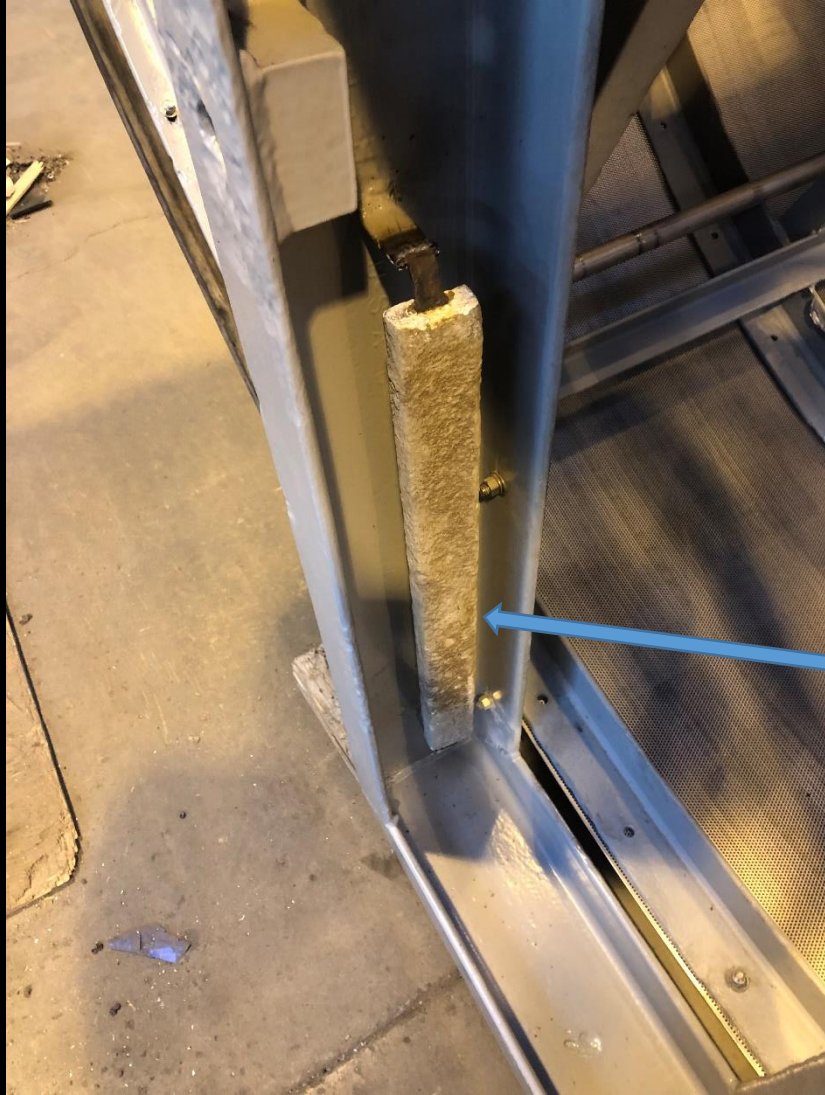
2 of the frames  
had be straighten.

Added back.
