Lower Granite Lock and Dam *Juvenile Bypass System (JBS) Primary & Secondary Dewatering Design and Construction*

2019 Pacific NW Fish
Screening and Passage
Workshop

September 19, 2019

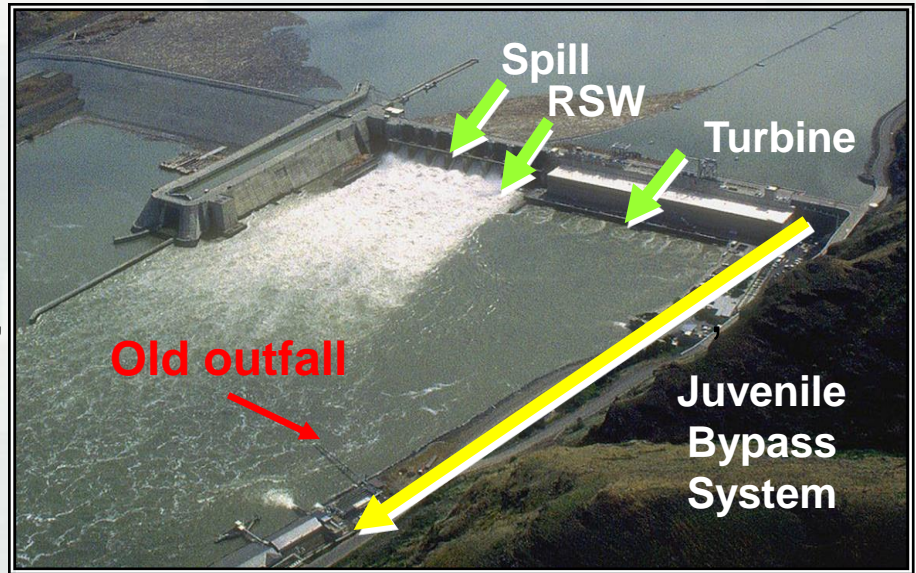
■ Existing System

- ▶ 10" orifices to downwell, to 1700 ft of pressure pipe, to upwell, to undersized dewatering screen

■ Purpose of Project

▶ Improve Survival

- New primary bypass outfall for return to river fish easier and in better location in the river

▶ Reduce Delay

- 10" orifices replaced by 14" orifices
- 2013 study should $\frac{1}{2}$ of the gatewell residence time for 14" compared to 10" orifice

▶ Reduce Injury

- Open channel transport with correctly sized dewatering & automatic cleaning system

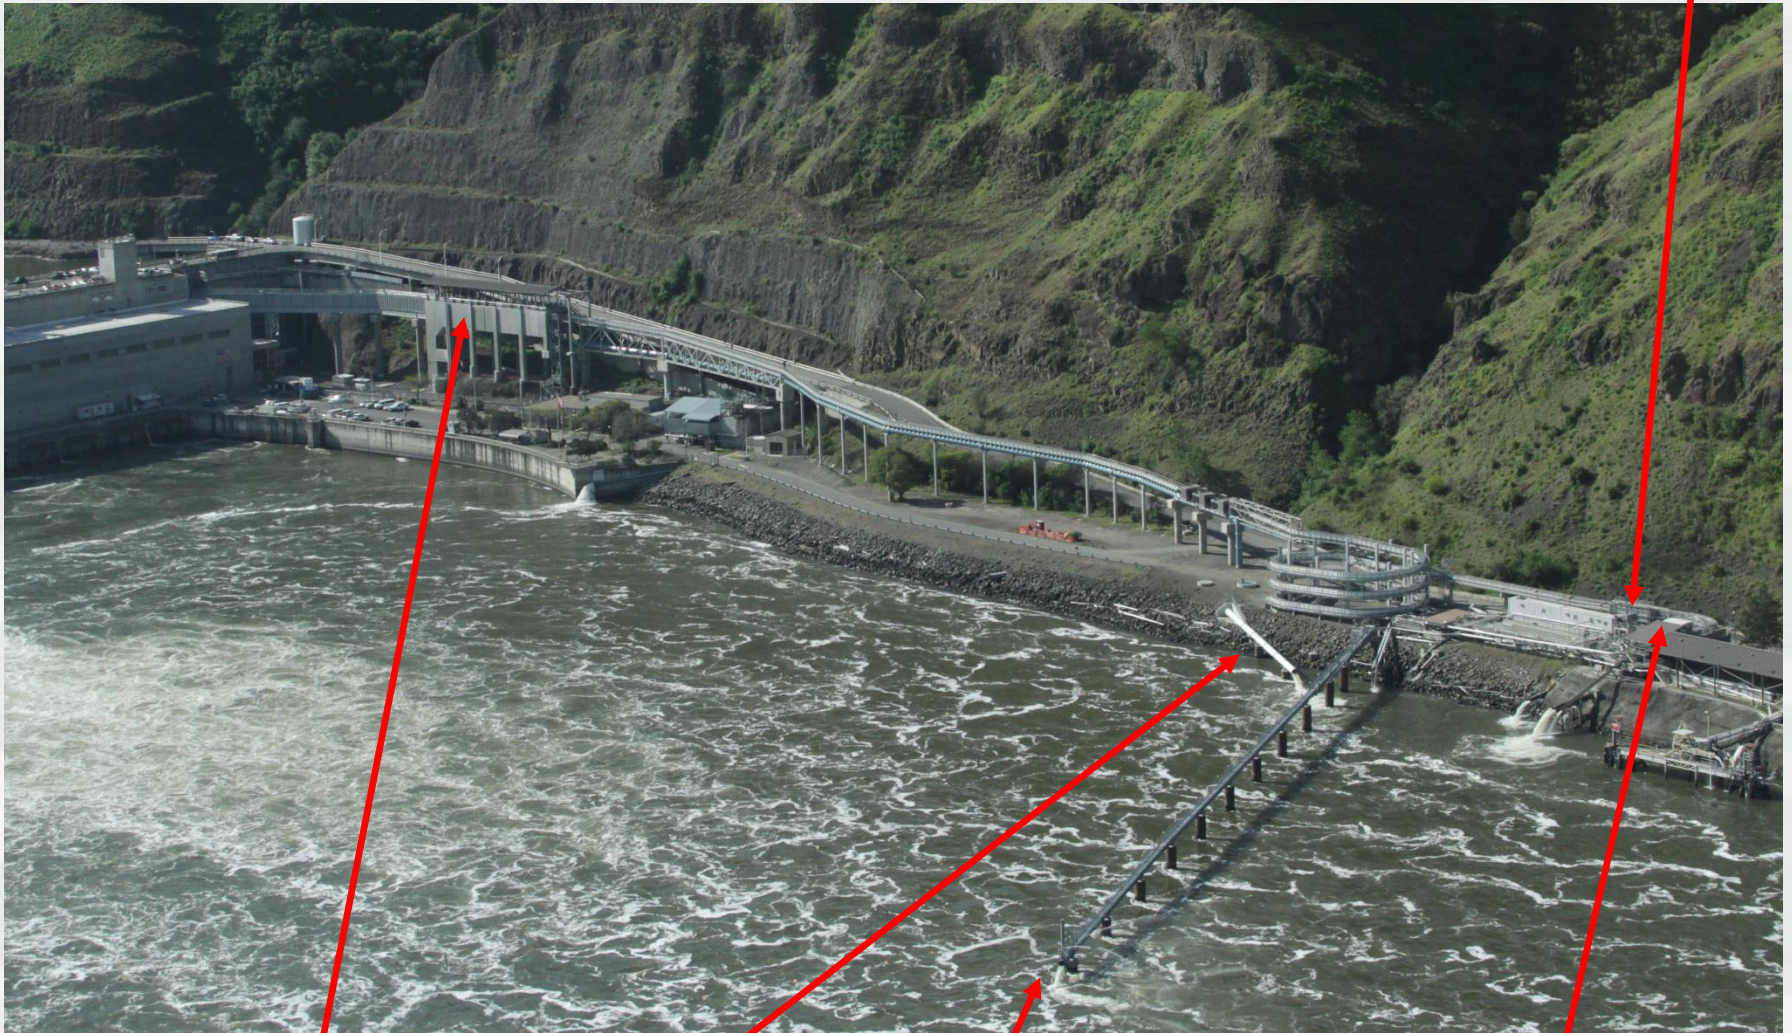
Secondary Dewatering

Primary Dewatering
Structure

Emergency Bypass Outfall

Primary Bypass Outfall

Existing
Separator

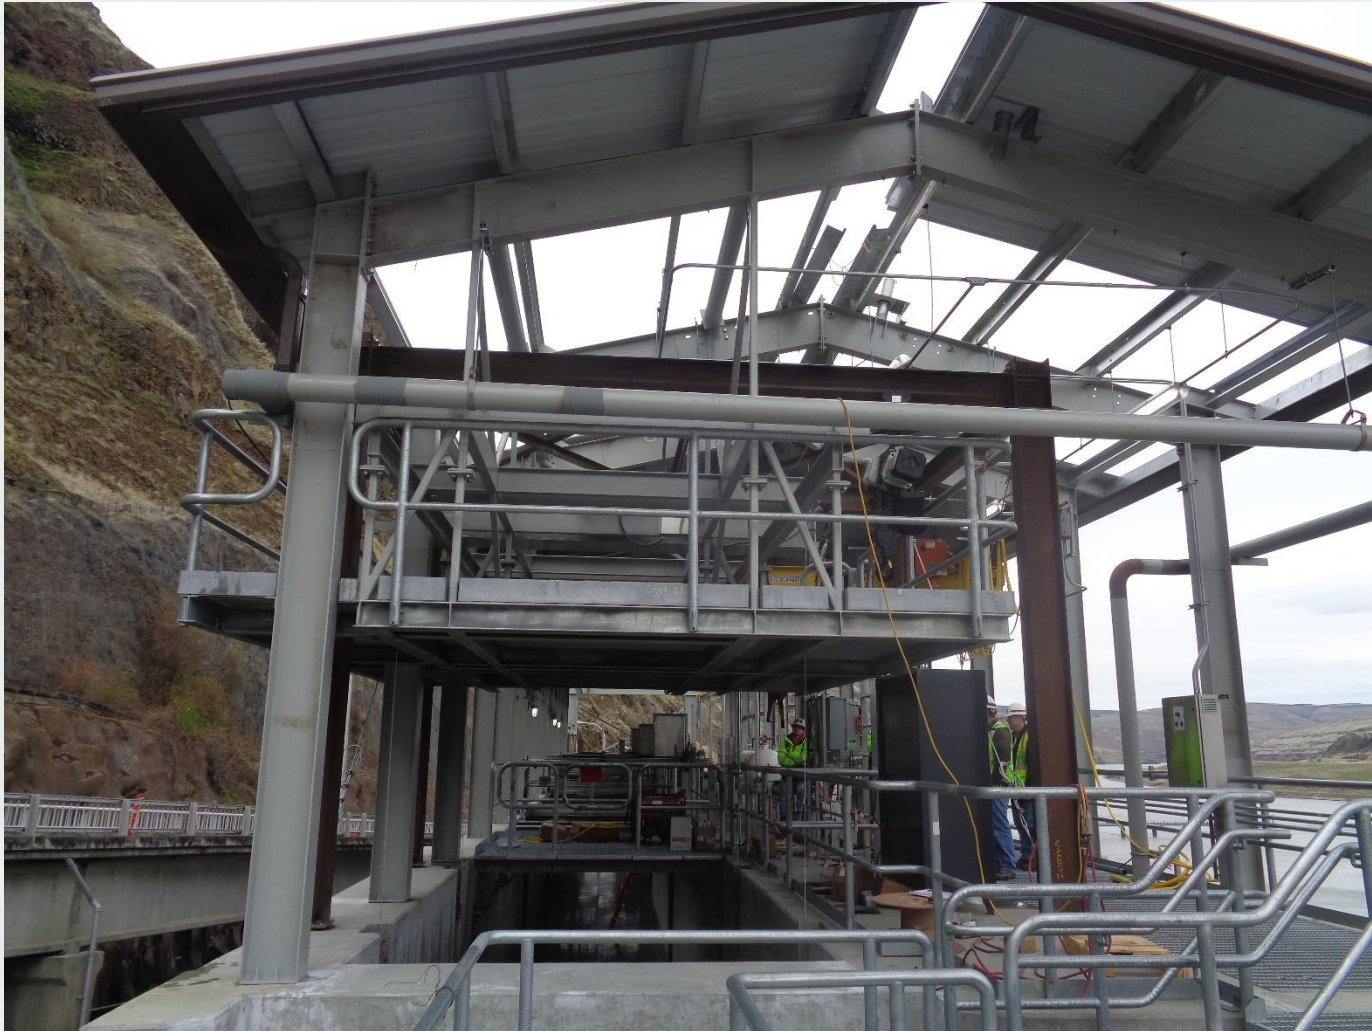
Primary Dewatering (PDS)

- Large structure with 365 cfs dewatering capacity

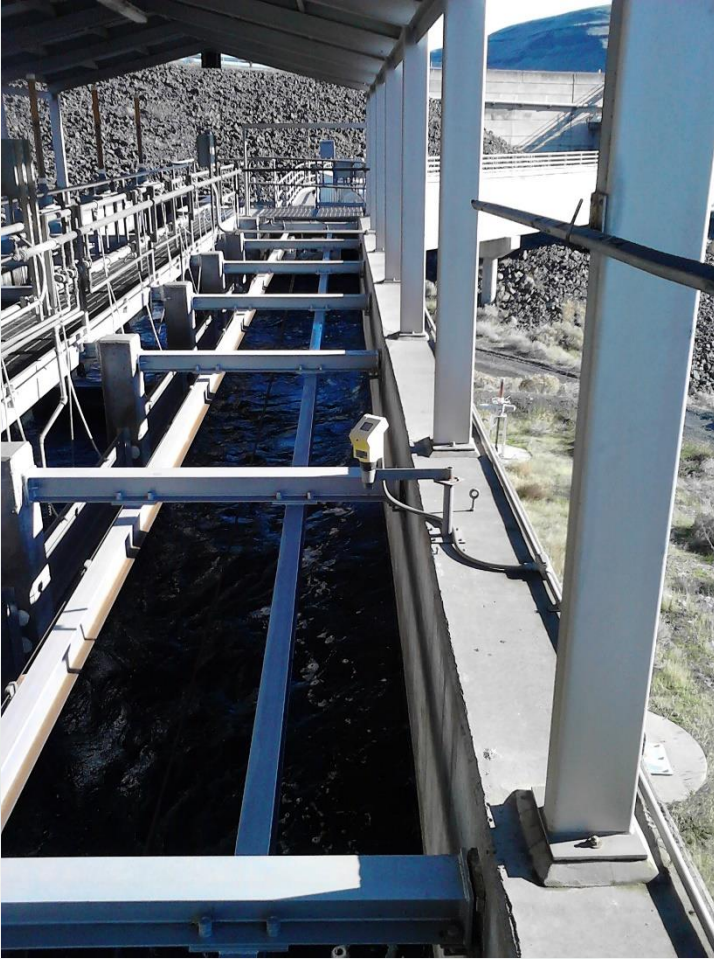
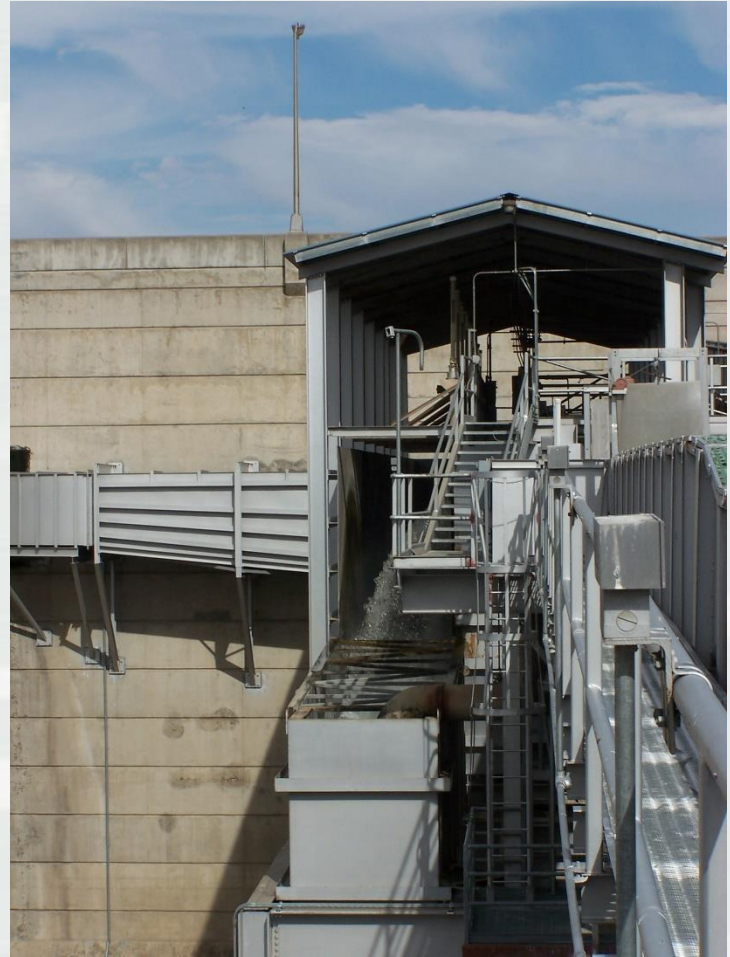
PDS similar design to Previous Designs

- Lower Monumental & Little Goose PDS similar

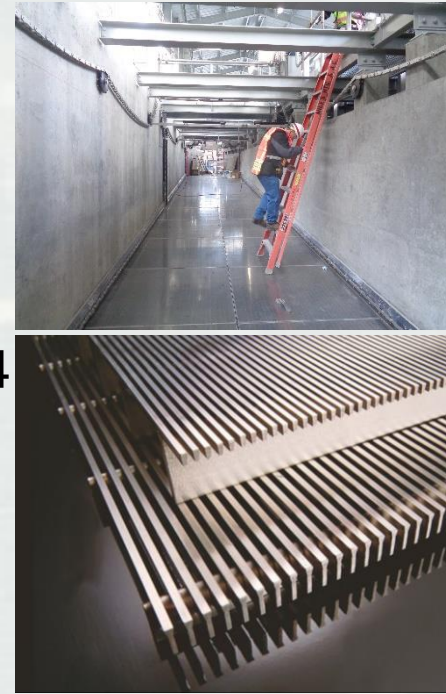
■ Sizing of PDS

- ▶ 14" orifices double the flow ~ 180 – 380 cfs into PDS and 25 – 40 cfs out to flume
- ▶ Meet NMFS criteria for active cleaned screens 0.4 fps approach implies at least 915 ft² of screen.
- ▶ Effective screen area 840 ft² floor screen and 100 ft² side screen
- ▶ Profile bar used for all screen in PDS

9 3x3 framed screens
each side

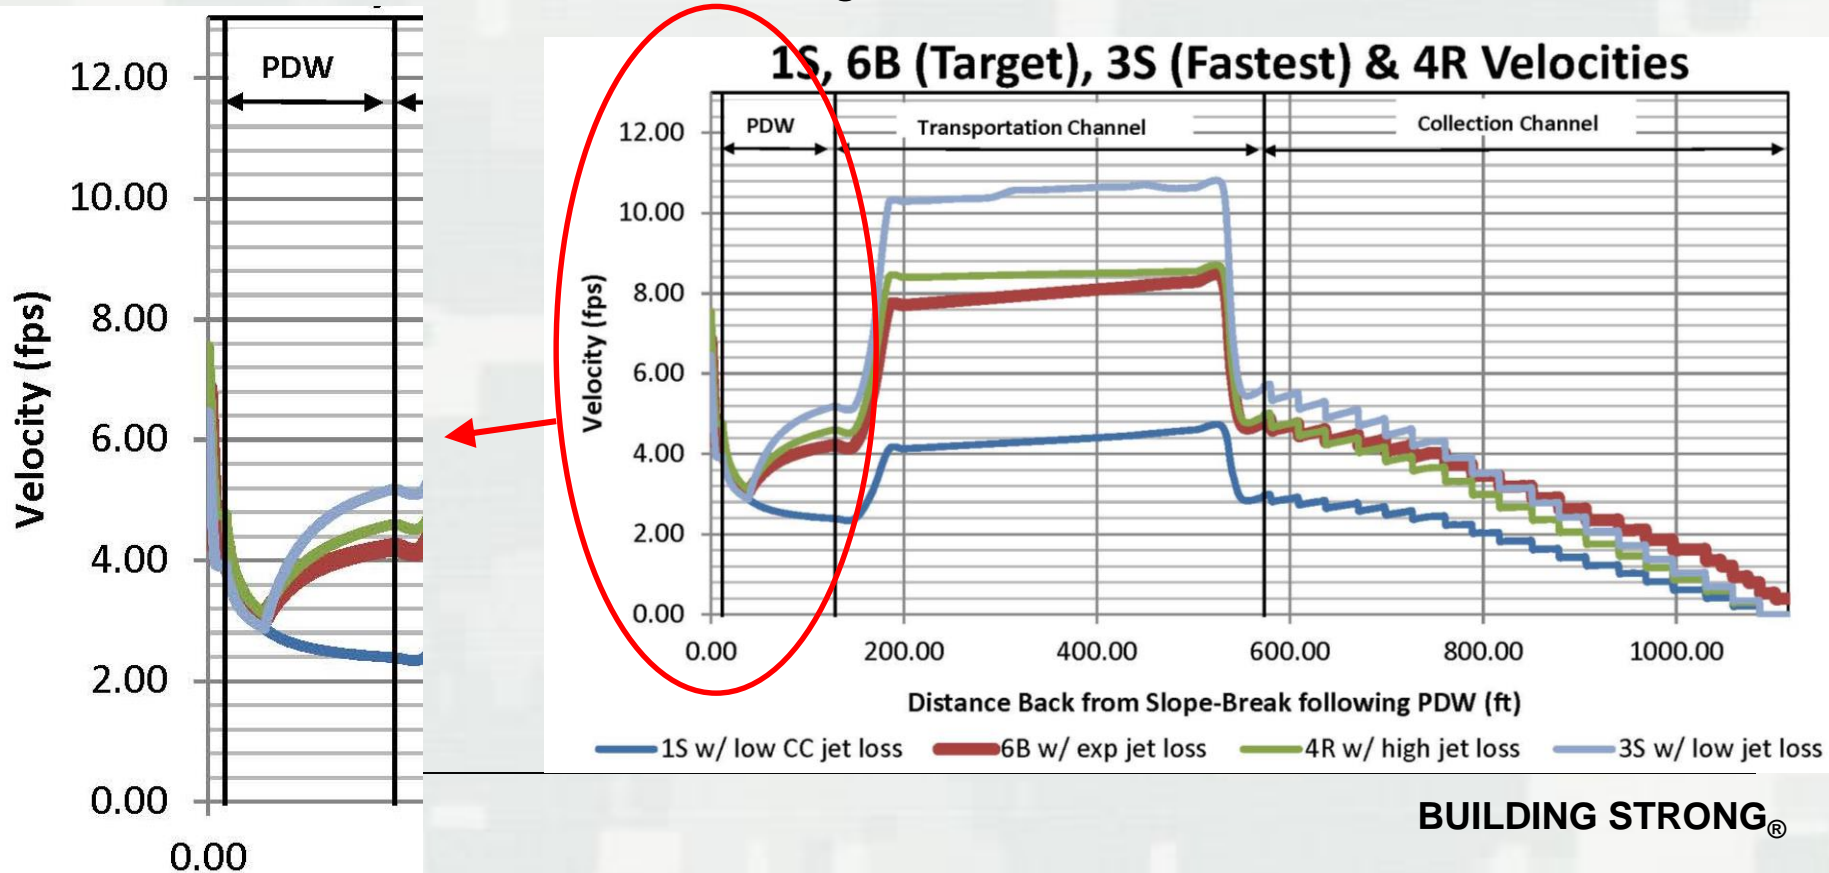
■ Design Velocities through PDS

- ▶ Due to shallow angle inclined screen discussed with NMFS to have a target PDS velocity of 3-5 fps despite transport between 6-12 fps
- ▶ Attempted to maintain near constant velocity and not violate 0.2 fps/ft acceleration criteria over range inflow conditions

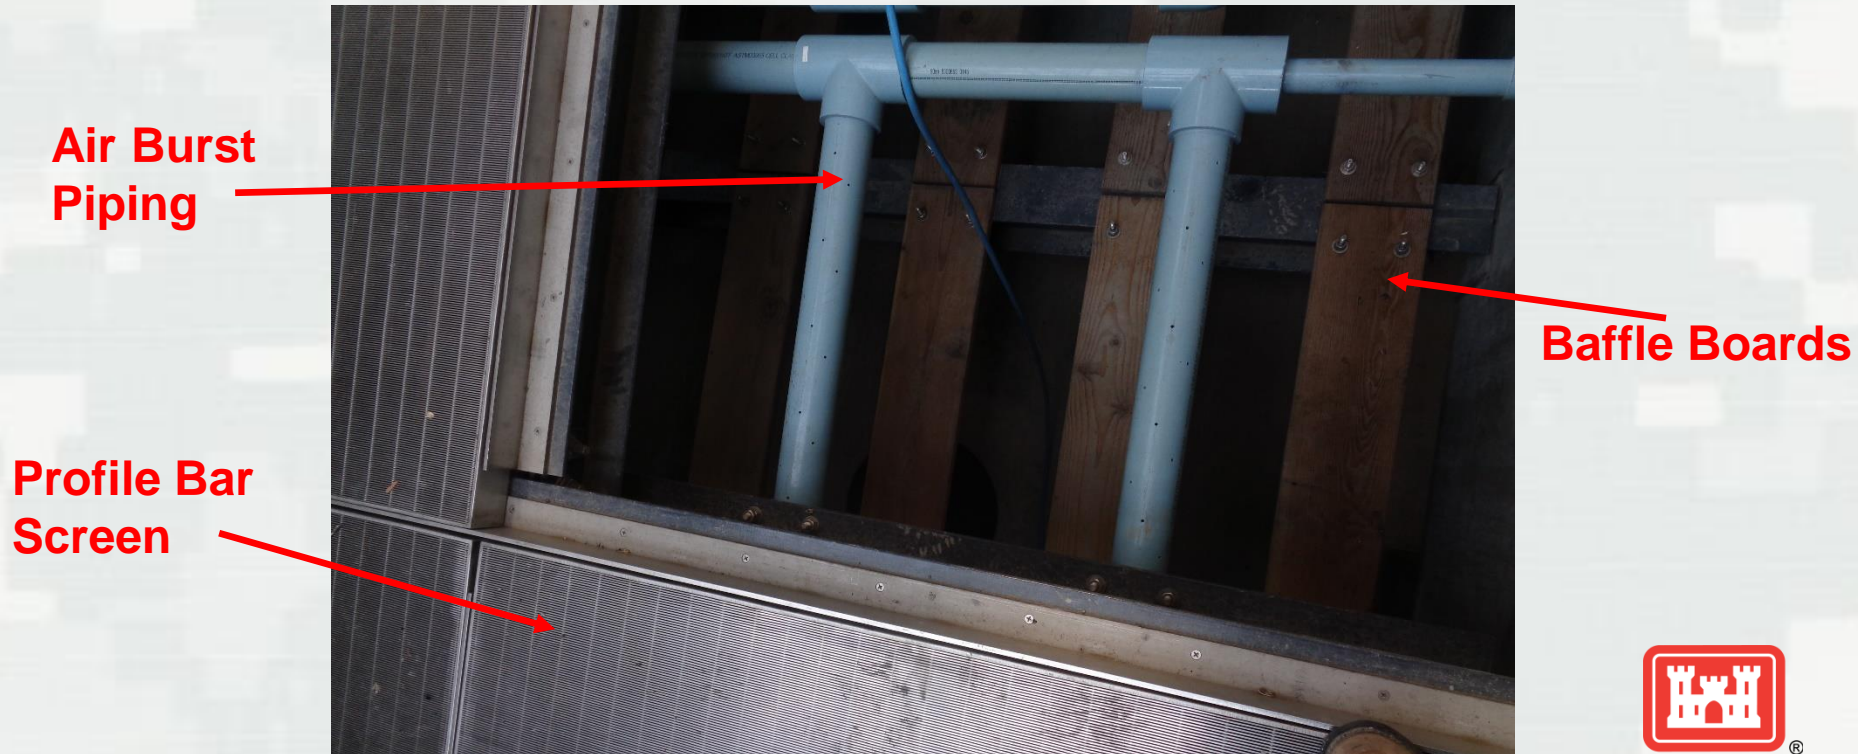
- Baffling

- ▶ Baffles boards used to break up water withdraws under screens
- ▶ No baffling under profile bar screens
- ▶ Approach similar to Lower Monumental and Little Goose

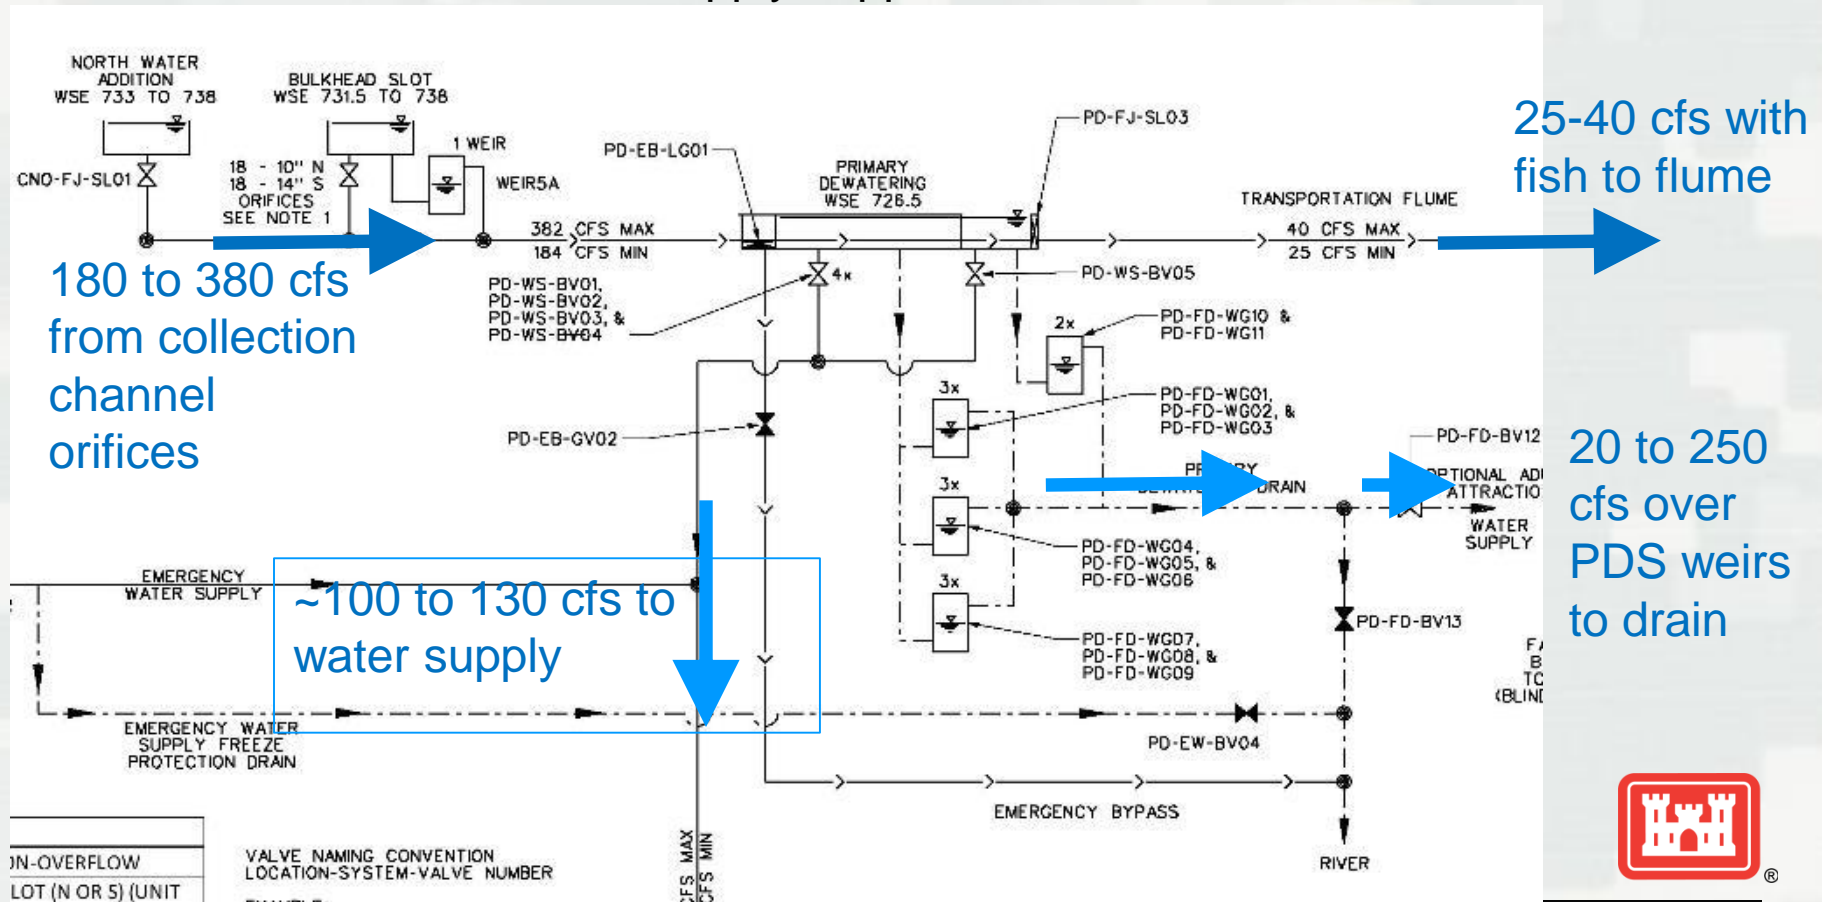
■ Use of Screened Water

- ▶ Water pulled through screen supplies water supply for JFF
- ▶ Water not used for water supply supplements adult ladder attraction water

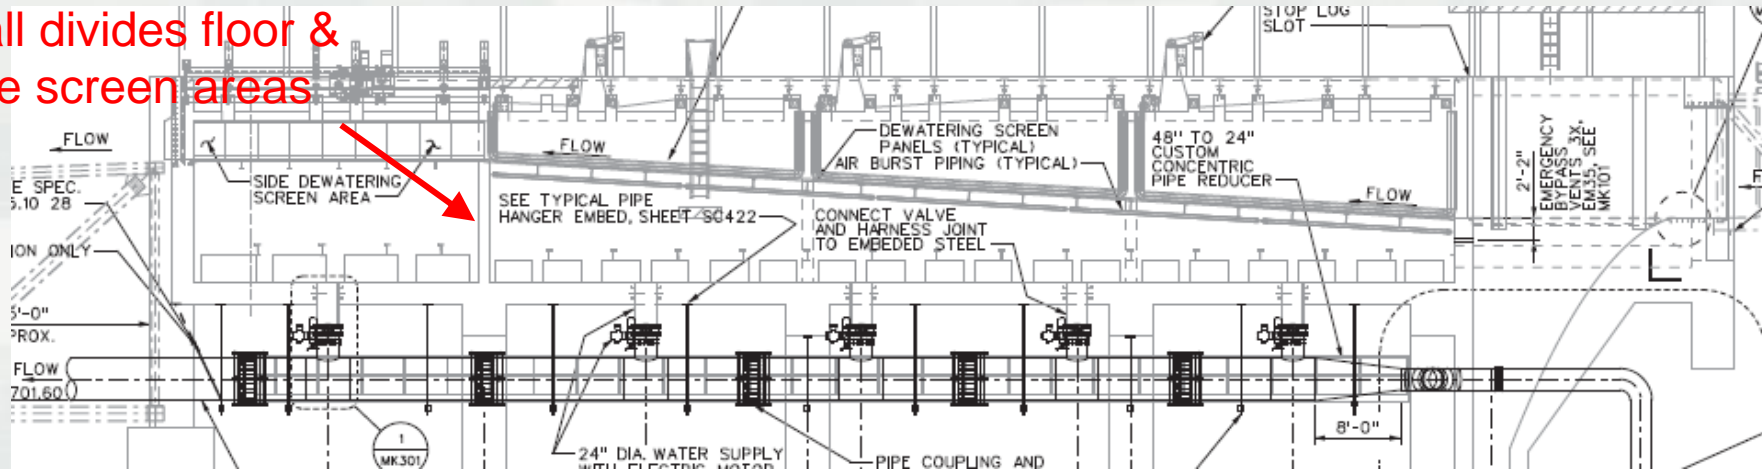
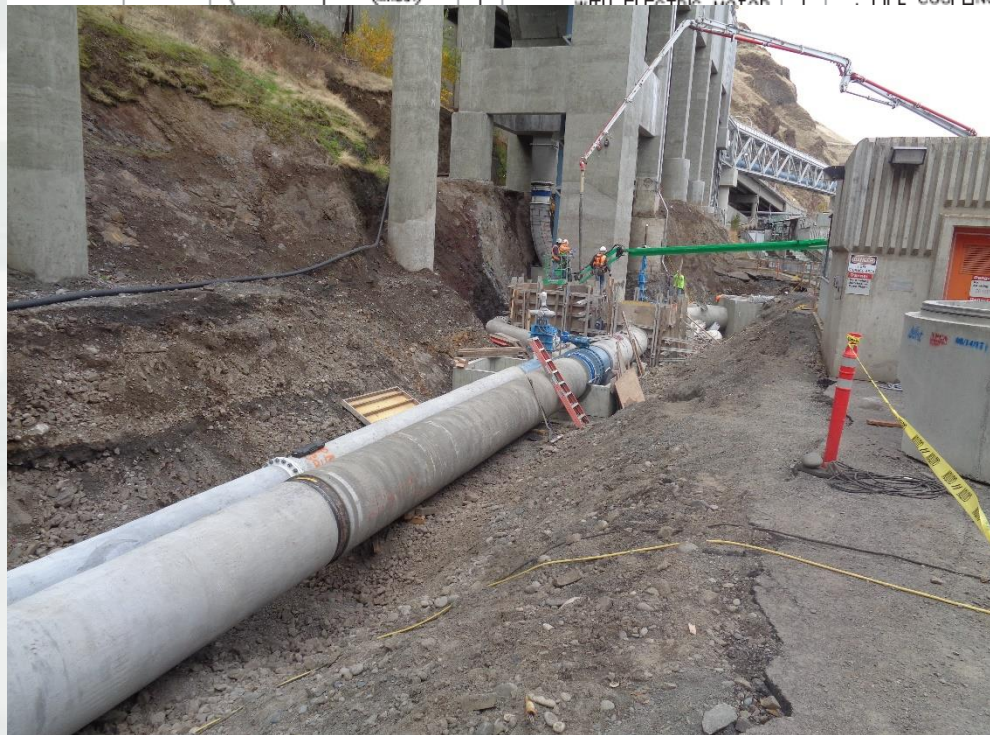
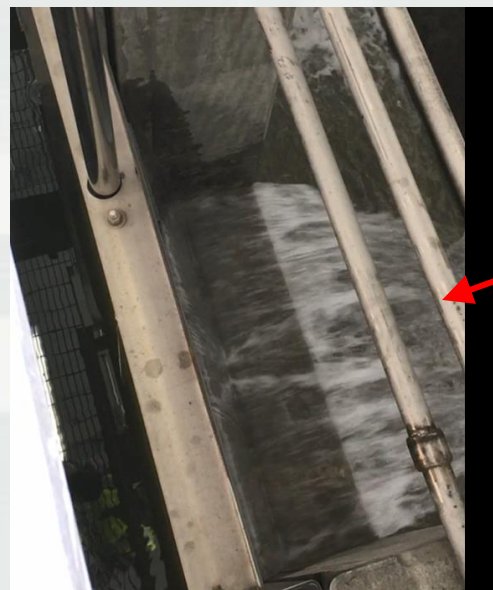
Primary Dewatering – Use of Screened Water

Wall divides floor & side screen areas

Flow over weir into drain channel

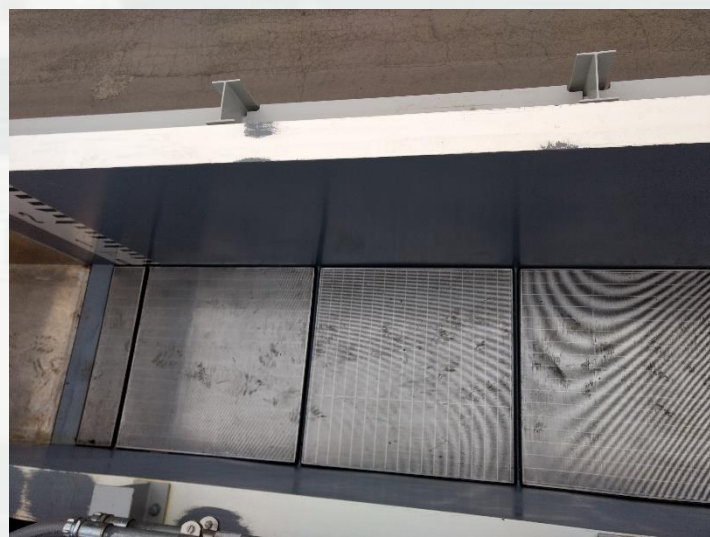
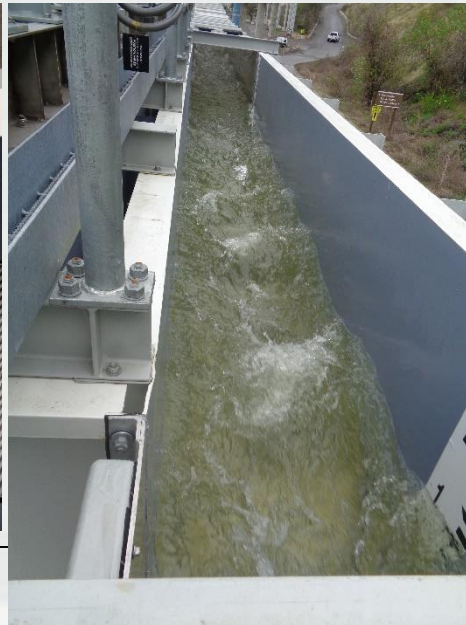
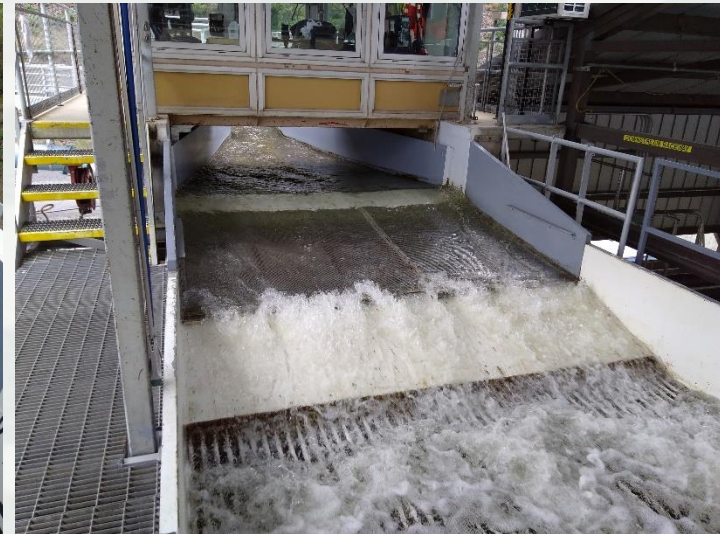
Secondary Dewatering (SDW)

- SDW just prior to existing facility
 - ▶ Original design had only 15 cfs being pulled out at porosity control prior to existing separator
 - ▶ Therefore need to pull out up to 22 cfs if going to existing facility
 - ▶ Size to meet 0.4 fps approach
 - ▶ Uses bubblers for cleaning
 - ▶ Maintains steep slope to maintain supercritical flow

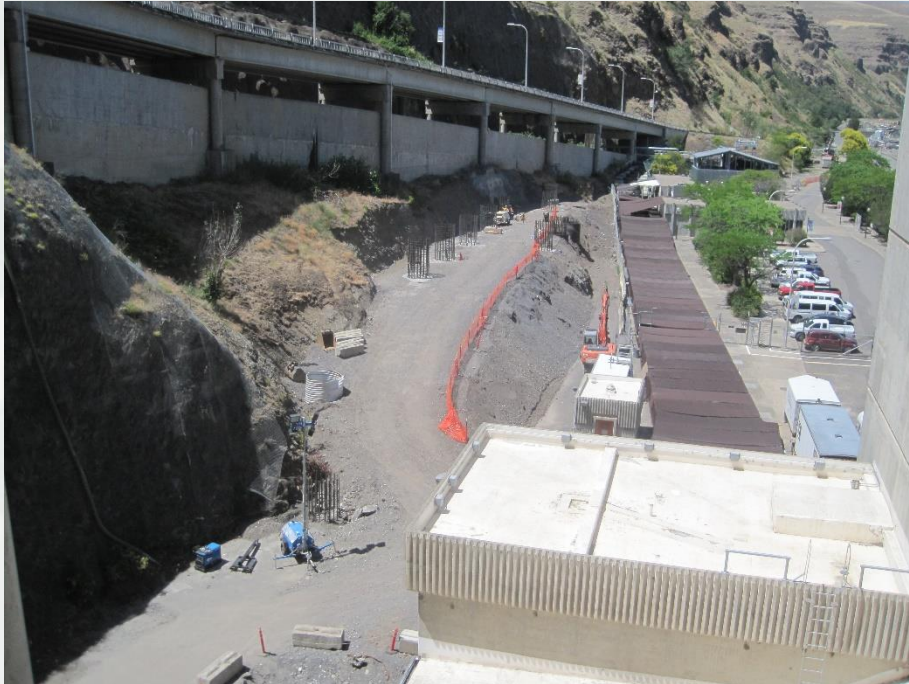
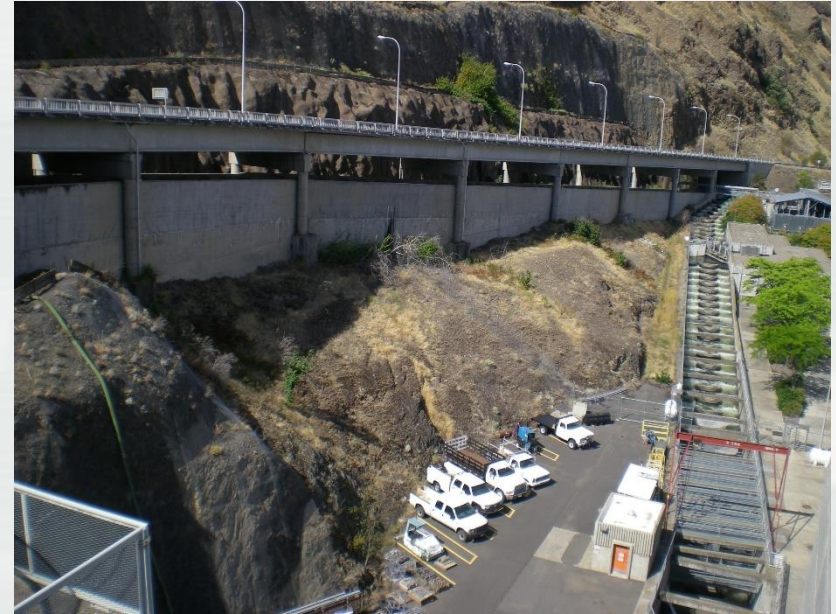
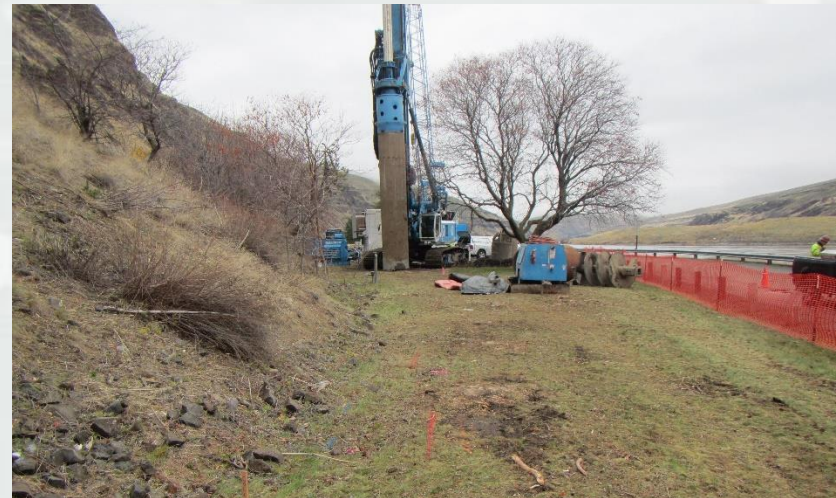
- PDS was in difficult location to install support piers
 - ▶ ISSUE: The larger drilled shaft equipment could not access the areas needed for install piers for PDS
 - ▶ RESOLUTION: The steep hill had to be benched with some cut and mostly fill.

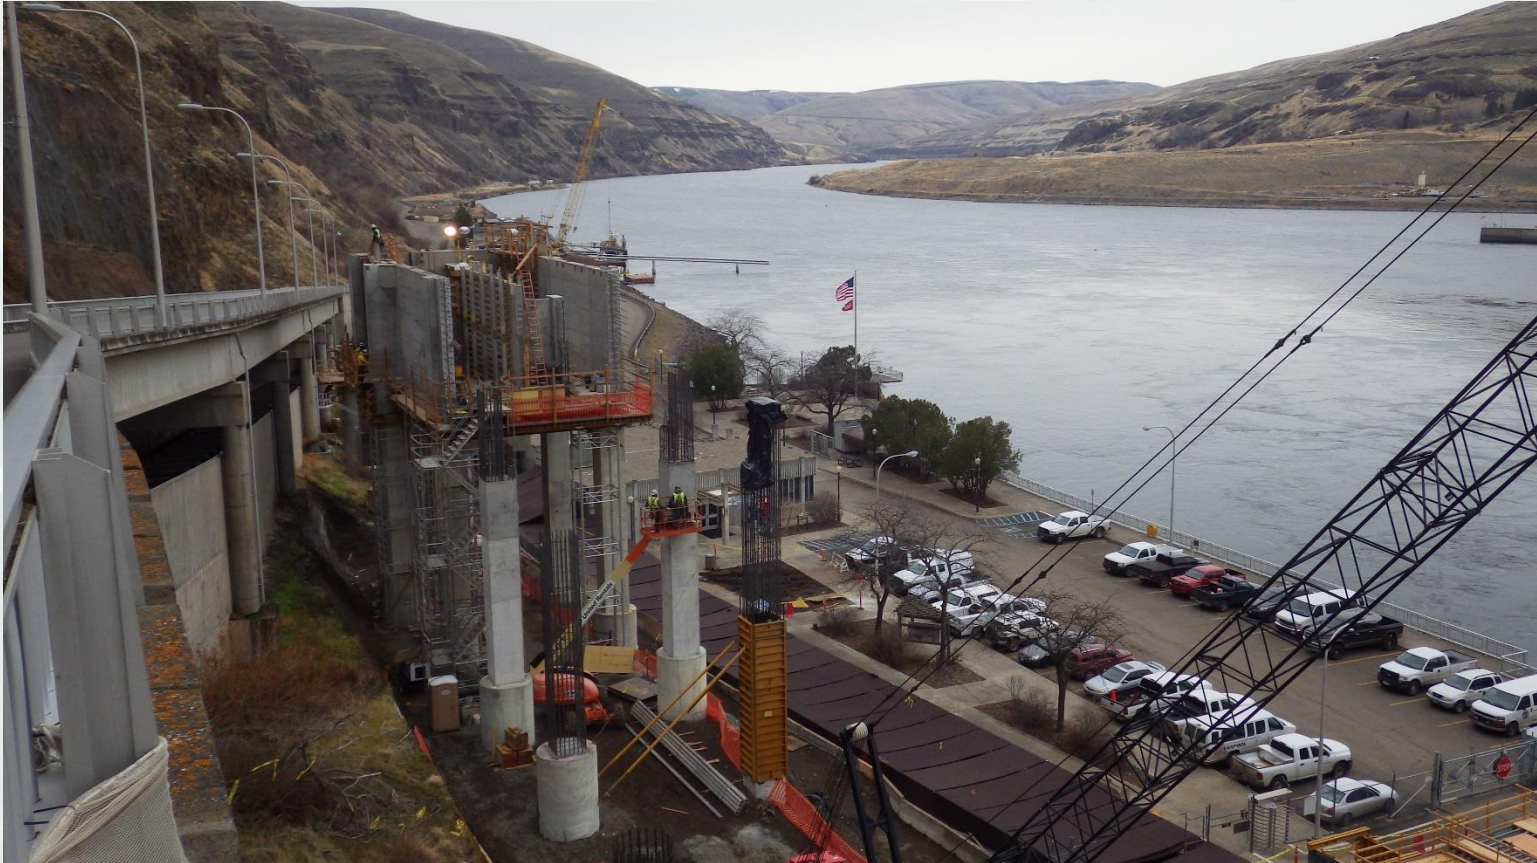
- Construction access for PDS was limited

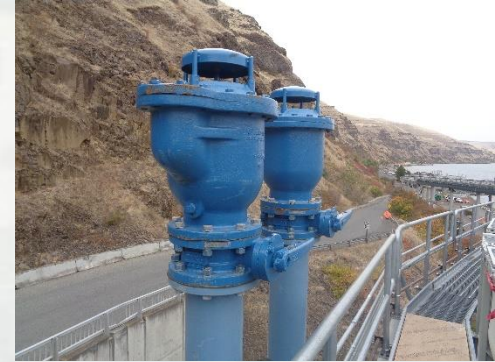
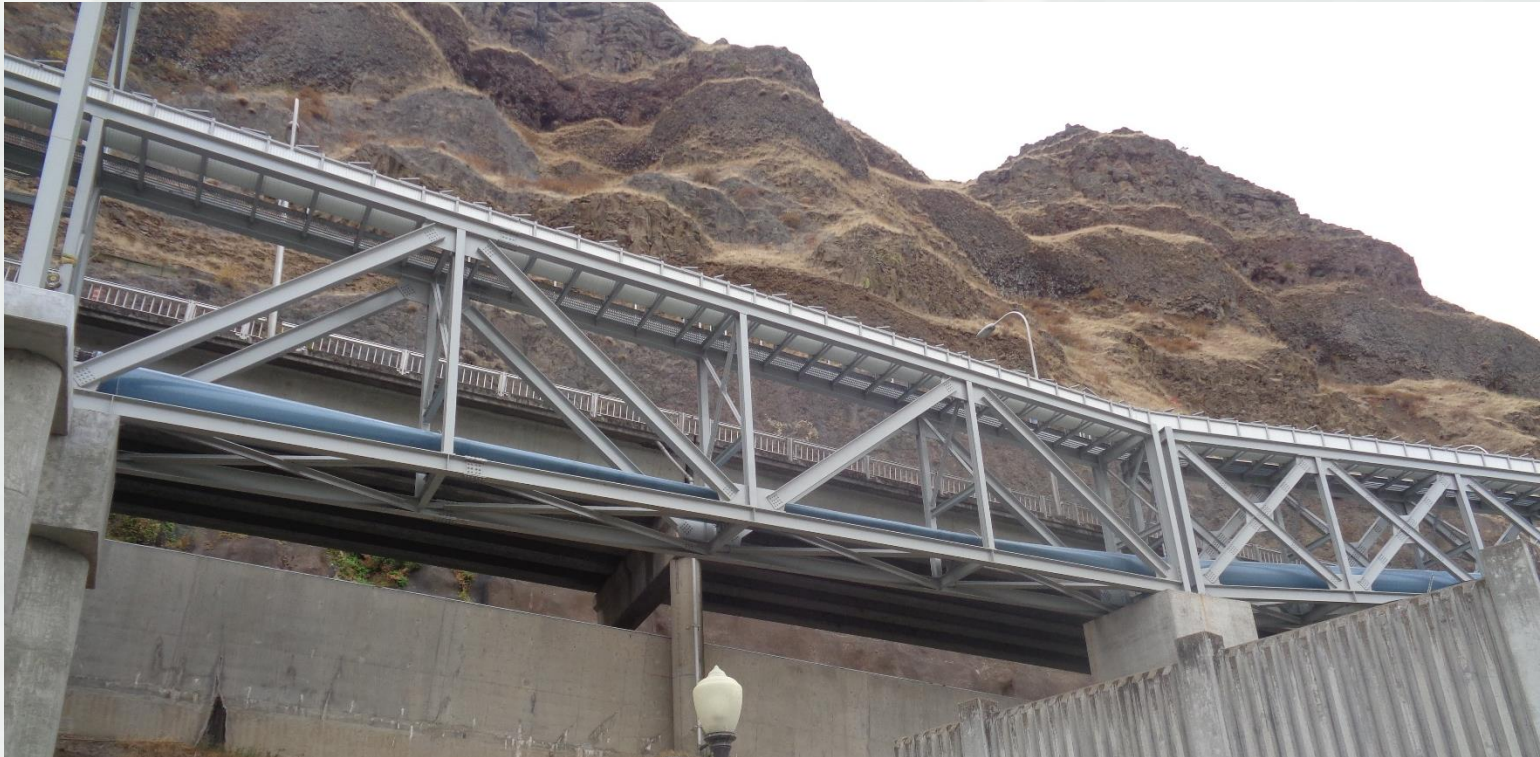
- PDS water supply crushed by vacuum
 - ▶ ISSUE: Contractor had air release/vacuum breaker isolated during pressure testing and then emptied pipe.
 - ▶ RESOLUTION: Contractor took hit and refabricated pipe and recovered lost schedule.

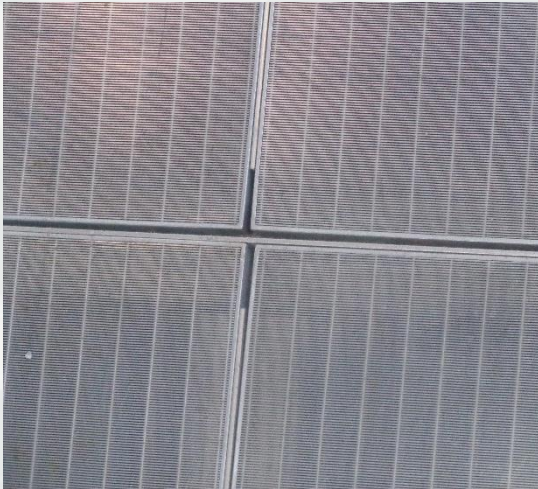
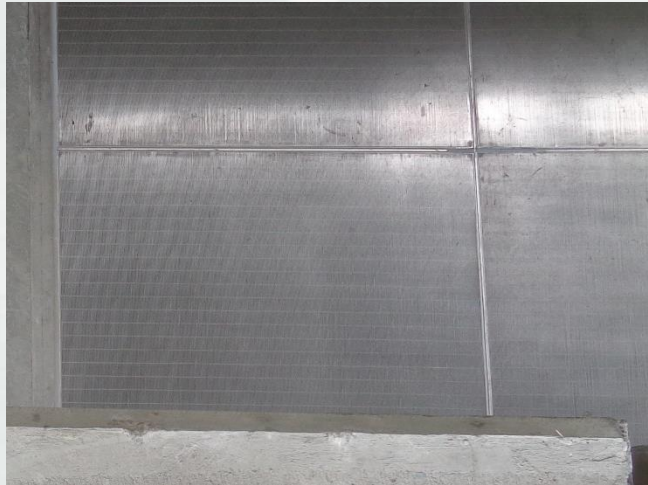
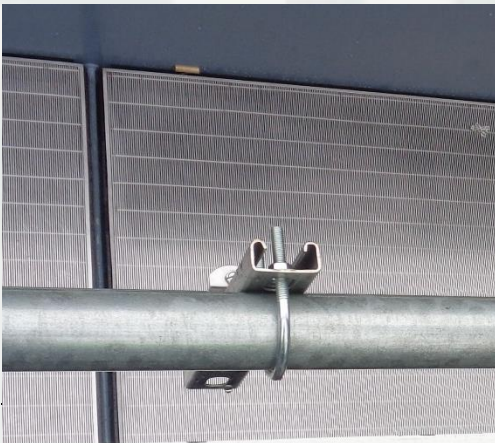
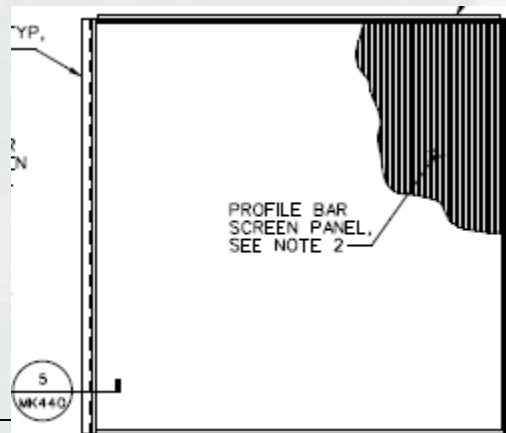
- PDS & SDW gaps between screens
 - ▶ ISSUE: Gaps present potential injury issue especially in SDW.
 - ▶ RESOLUTION: Used caulk for PDS & UHMW for SDW to fill gaps.

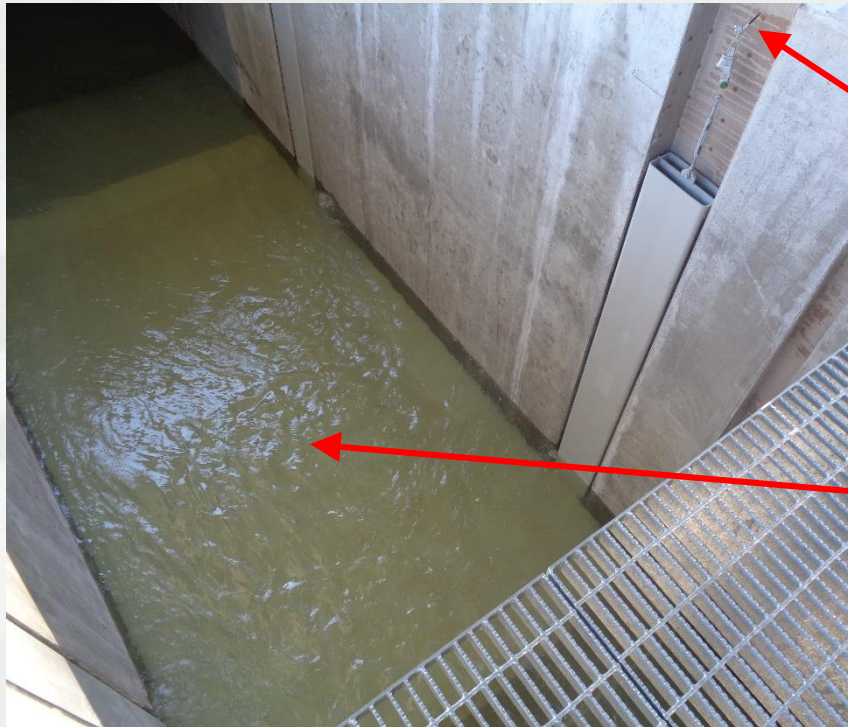
- PDS emergency cables broke during testing
 - ▶ ISSUE: Under-predicted water pressure loading to break off EMB plate off seal.
 - ▶ RESOLUTION: Had to abandon cable system due to time and do temporary hoists & slow down initial lift.

1 of 4 cables which broke in later lift

Hatch plate over EMB downwell

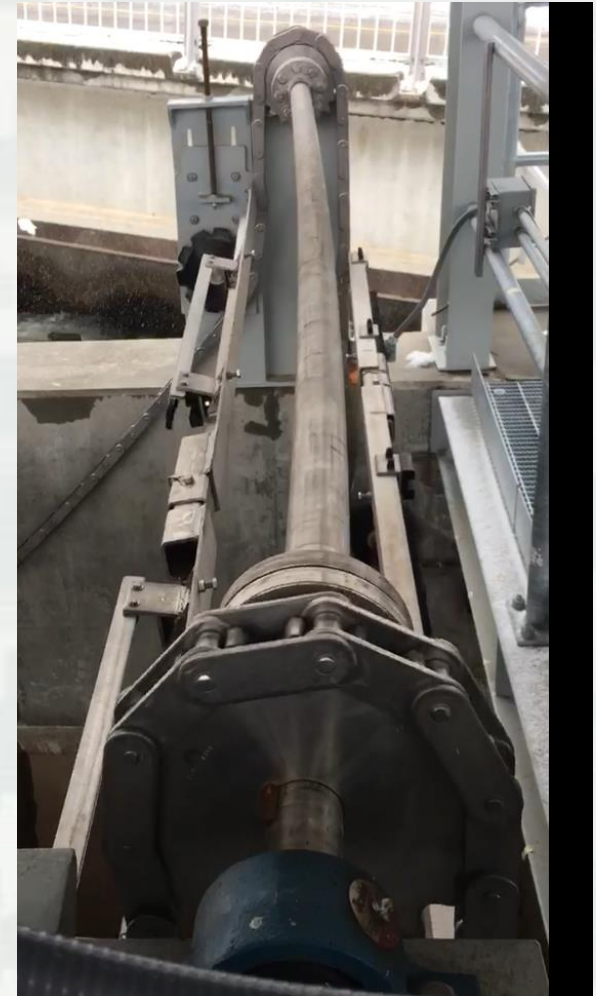
- PDS water control unstable
 - ▶ ISSUE: Initial control used a different downstream WSE for the weirs behind the side screens (Group D). Also frequency of weir adjustment was too quick to get response from water surface.
 - ▶ RESOLUTION: Initially used Weir Group D in manual & then made software change to correlate with other weir groups. Also made adjustment frequency settable by operator (60 sec worked well (initial 15 sec)).
- Floor Screen Brush bent
 - ▶ ISSUE: Floor brush got stuck on debris and was ran backwards to clear it. However pipe between chains bent.
 - ▶ RESOLUTION: Replace connecting pipe with larger pipe for all 3 brushes. Limit brush head movement so doesn't jam if need to run backwards.

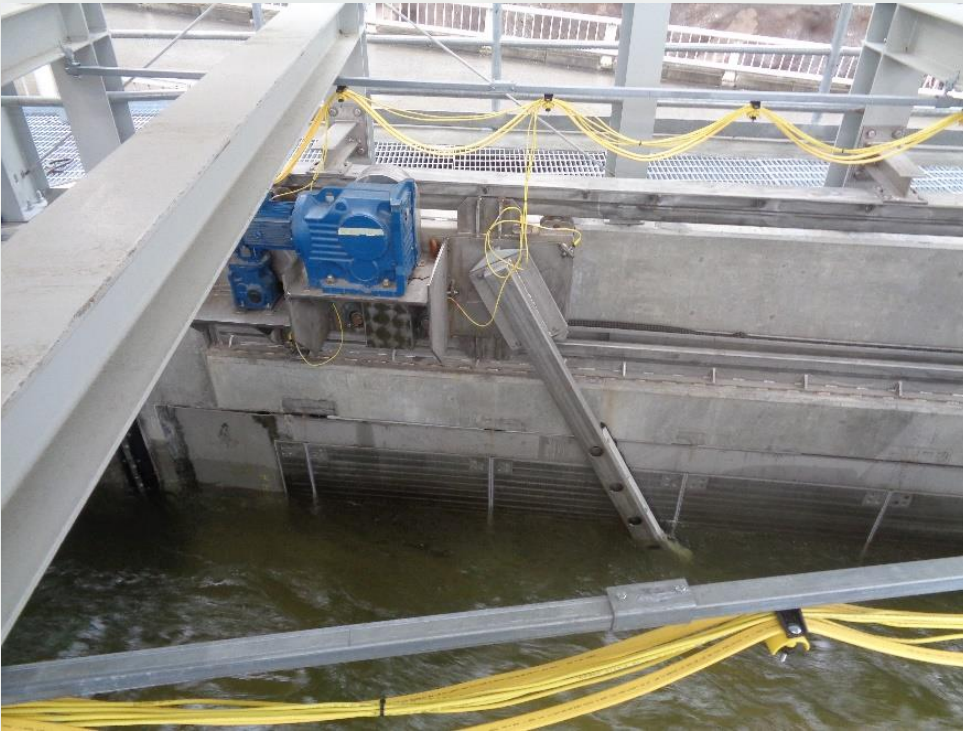
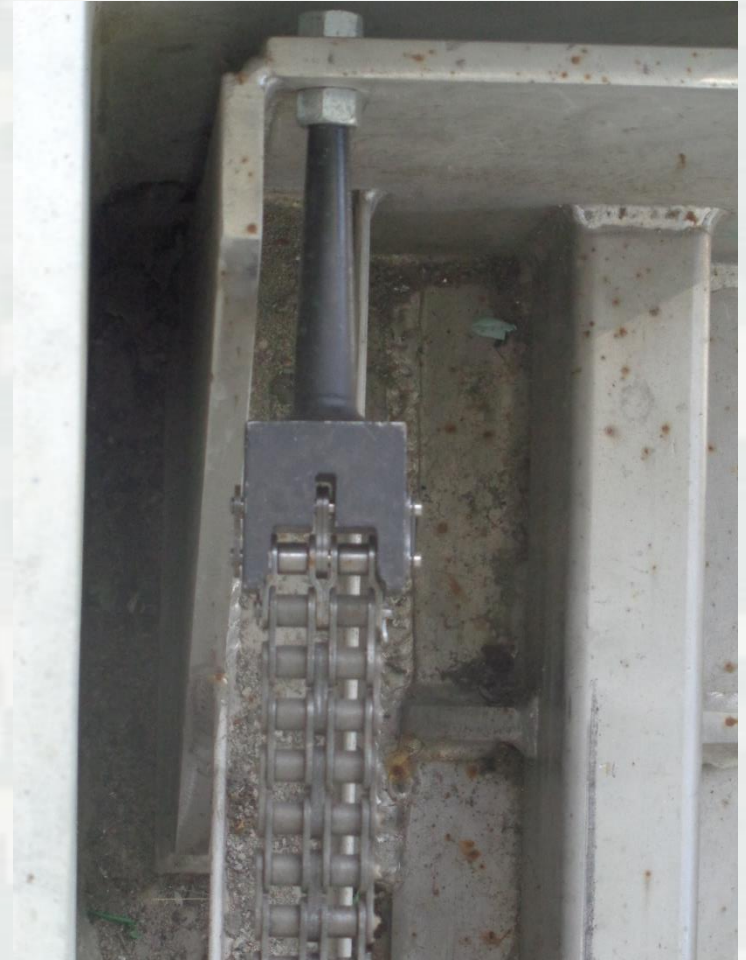
- Chain broke on Side Screen Cleaners
 - ▶ ISSUE: Connection of chain broke when changing directions.
 - ▶ RESOLUTION: Improved connection & added pause to direction changes in programming.

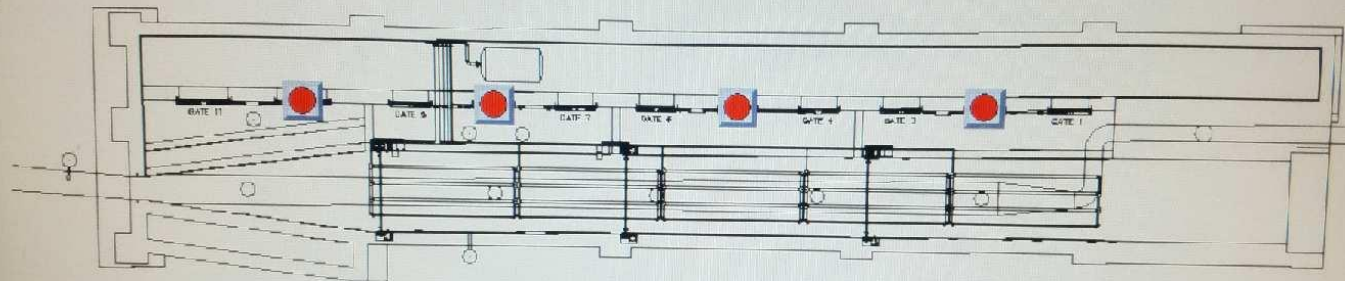
PRIMARY DEWATERING WEIR CONTROL

PDS
WEIR GROUP D
PDS-WGD
MANUAL

PDS
WEIR GROUP C
PDS-WGC
AUTOMATIC

PDS
WEIR GROUP B
PDS-WGB
AUTOMATIC

PDS
WEIR GROUP A
PDS-WGA
AUTOMATIC

WEIR GROUP D
ELEV. (WSE)
PDS-WGD-LI
725.728

WEIR GROUP C
ELEV. (WSE)
PDS-WGC-LI
725.845

WEIR GROUP B
ELEV. (WSE)
PDS-WGB-LI
725.853

WEIR GROUP A
ELEV. (WSE)
PDS-WGA-LI
725.875
